Report on Blackout in Turkey on 31st March 2015

– Final Version 1.0 –

Project Group Turkey

21 September 2015

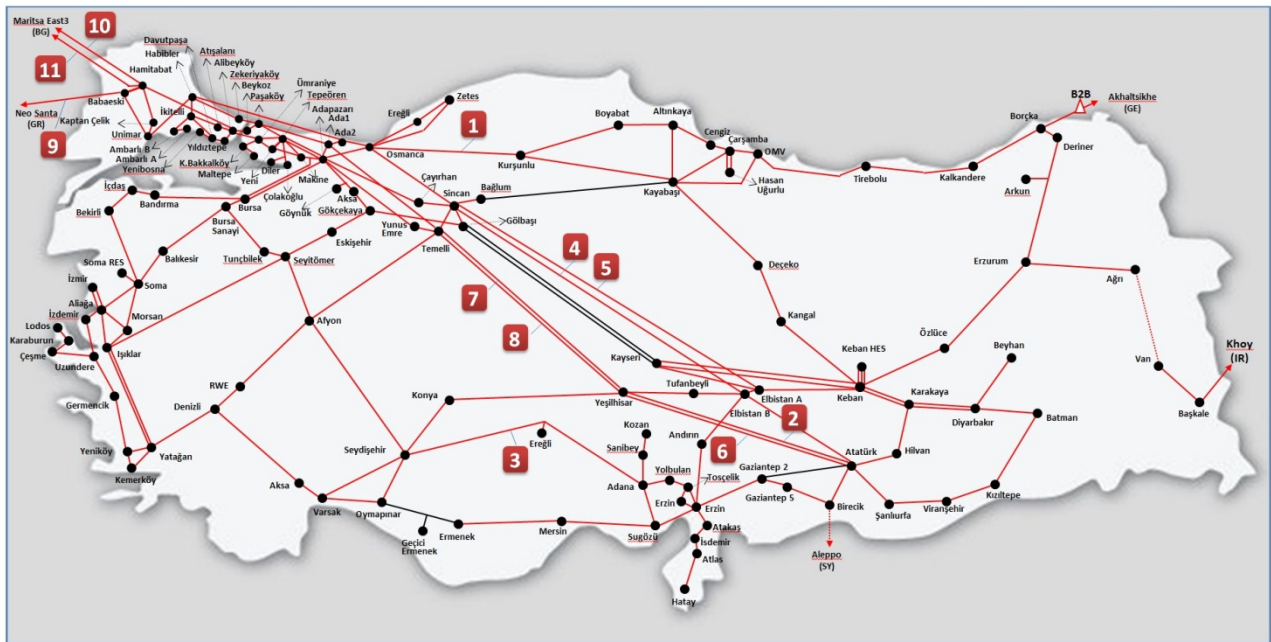
Figure 1: Turkish transmission system map with sequence of events

The Western subsystem, with a pre-disturbance load of 21870 MW and import from Bulgaria of around 500 MW, underwent a power deficit of 4700 MW (i.e. 21%). This sudden imbalance caused the loss of synchronism with the CE power system and the separation from it by tripping of the three interconnection lines with the Bulgarian and Greek grids by the out-of-step function of the corresponding tie-lines protection relays approximately 1 sec. after the separation of two subsystems in Turkey. During the frequency drop from 49 Hz to 48.4 Hz the underfrequency load shedding relays disconnected about 4800 MW of load, supplemented by the disconnection of 377 MW of load by the CE-TR interface Special Protection System (SPS). After a short stabilisation of a few seconds the frequency, however, continued to decay due to the tripping of several generators at frequencies above 47.5 Hz which is the frequency level specified by the Turkish Grid Code for generators to remain connected for at least 10 minutes. This caused the collapse of the Western subsystem in around 10 sec.

The Eastern subsystem, with a pre-disturbance load of about 11080 MW, remained with a surplus of generation of approx. 4700 MW (~ 42%). In spite of the disconnection of several generators on overfrequency it also collapsed within a few seconds.

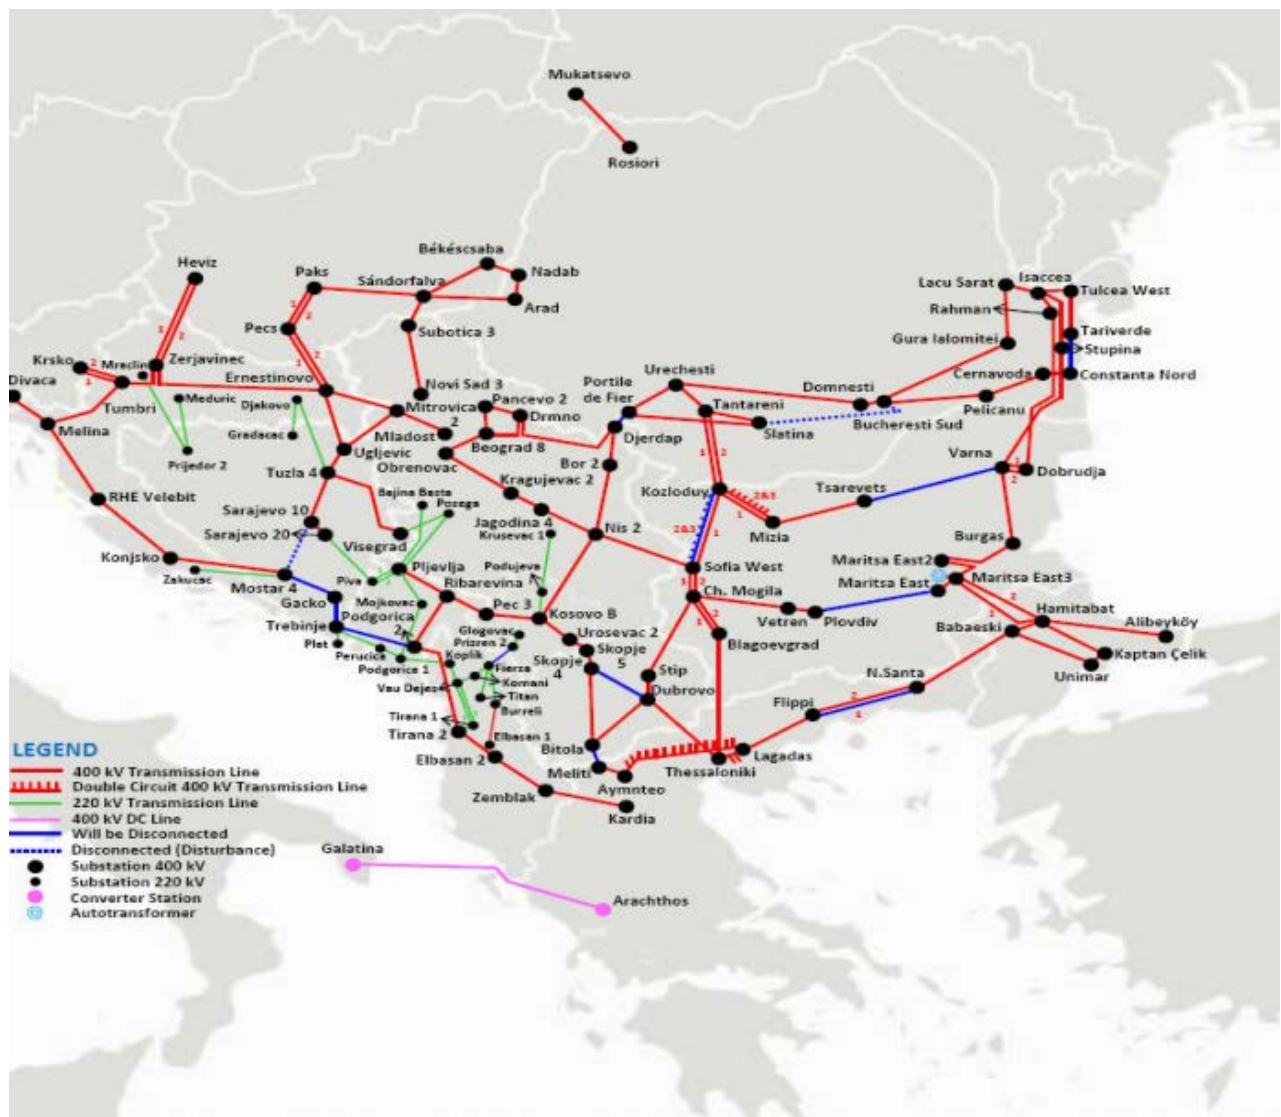
The 220 kV and 400 kV lines which were in maintenance before the blackout in southeast Europe are shown in Figure 2. The topology of the network, i.e. scheduled outages, was agreed among all South Eastern TSOs according to the standards of the RG CE Operation Handbook. This procedure includes - besides other procedures - the (N-1) security of the interconnected system. However, each TSO is only responsible for the security of its own area and, consequently, a complete (N-1) security analysis is performed mainly for the own power system.

Figure 2: South East CE Transmission System with scheduled outages included

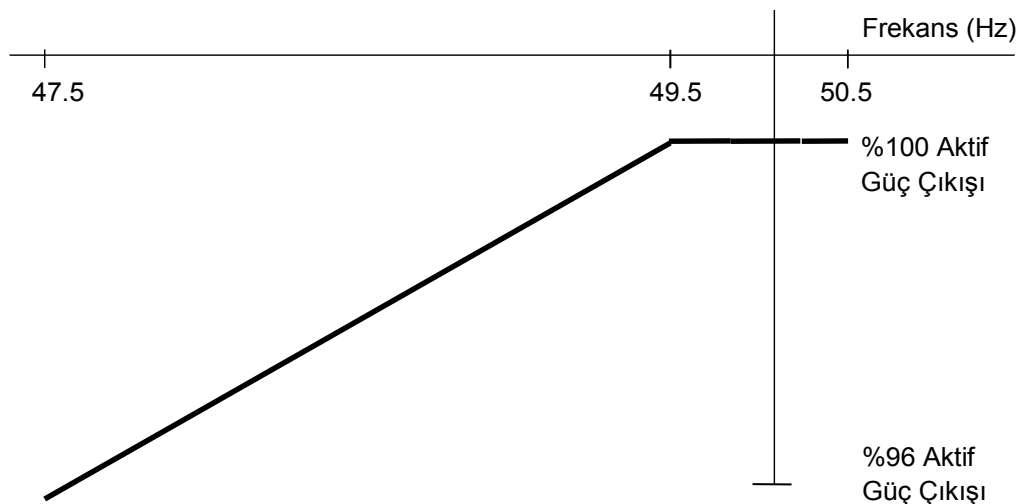
According to the Turkish Grid Code in force and in line with the Figure 3, the units should have the capacity to:

- generate constant active power output for the system frequency changes within the range 50.5 to 49.5 Hz, and
- generate active power at a level higher than the linear characteristic values for system frequency changes within the range 49.5 to 47.5 Hz
- in the case that the grid frequency is in the range of 49.5 Hz – 50.5 Hz, the output power should maintain 100% constant value and no more than 1 % output power drop should occur against every additional 1 % frequency drop. This requirement applies to any ambient temperature under 25 °C (77 °F) for the gas turbines.
- Necessary measures should be undertaken to ensure that the active power output of the gas turbines, due to turbine speed reduction by decrease of the system frequency, does not drop below the linear characteristic shown in the figure.

Figure 3: Output power requirement against frequency. (The x-axis represents the frequency in Hz, whereas the y-axis represents the percentage of the active power output of the unit)

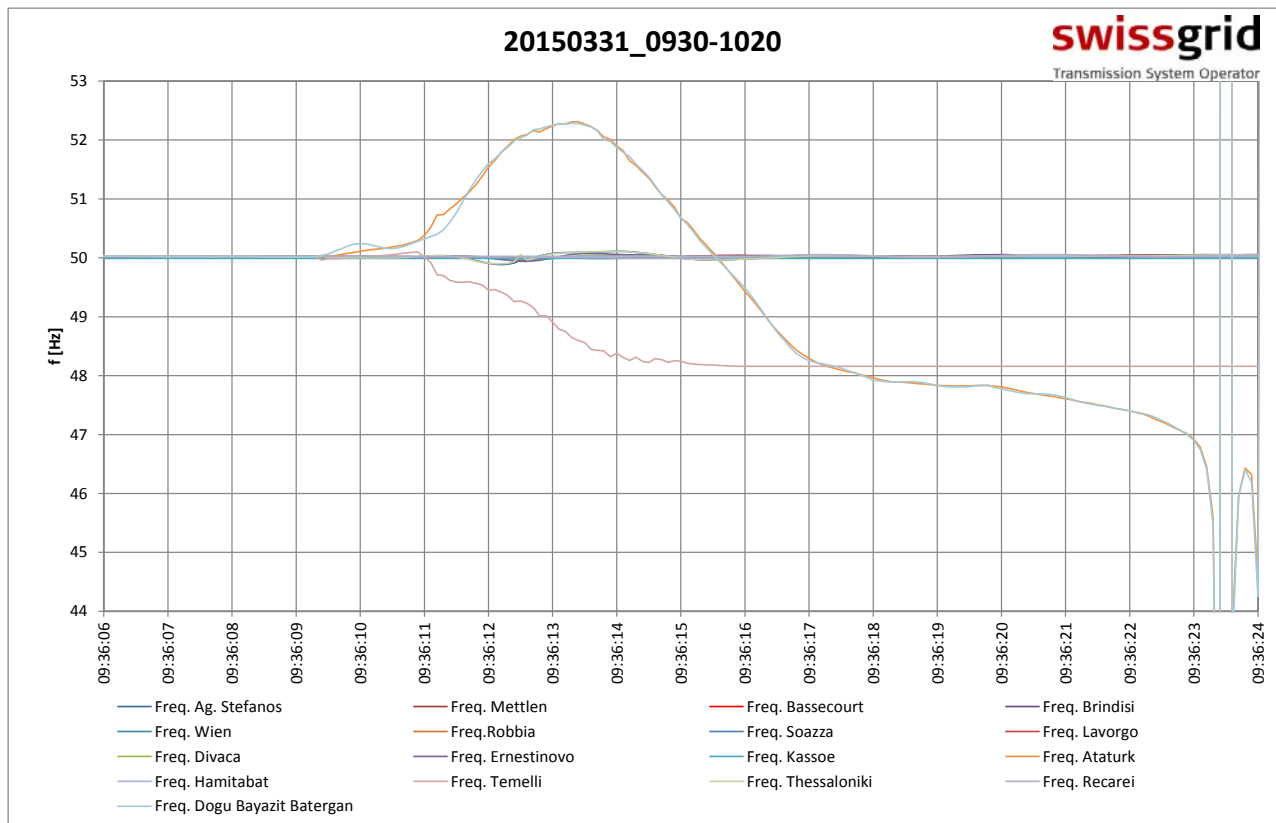
The system frequencies during the blackout are depicted in Figure 4 and Figure 5, respectively.

Figure 4: CE power system frequencies during complete blackout sequence

The Eastern power excess area (Dogu Bayazit & Atatürk) started accelerating up to 52.3 Hz with gradients of about 1 Hz/s. The Dogu Bayazit area seemed to be more weakly interconnected, but remained connected to the Atatürk island. At the same time the region around Temelli substation in the western part of Turkey was firstly accelerated too and remained synchronised with the system for a few seconds longer until 9:36:11 CET when in that island, due to power deficit, the frequency decreased with a gradient of about 500 mHz/s. At 9:36:13 CET, at a frequency value of 48.2 Hz, the recordings stopped to be consistent in the underfrequency island. At 9:36:23 CET the initially overfrequency east island collapsed at underfrequency values less than 47.0 Hz

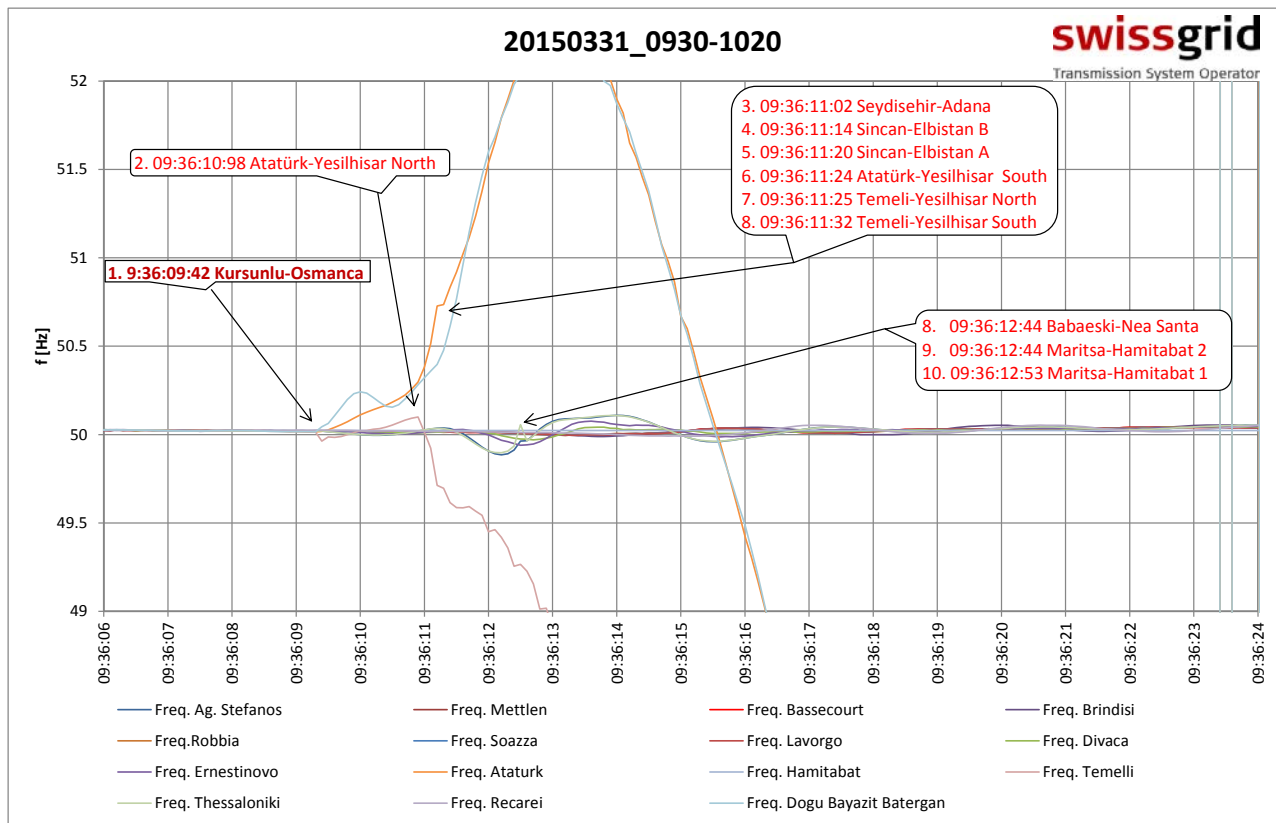
Figure 5: CE power system frequencies during system separation

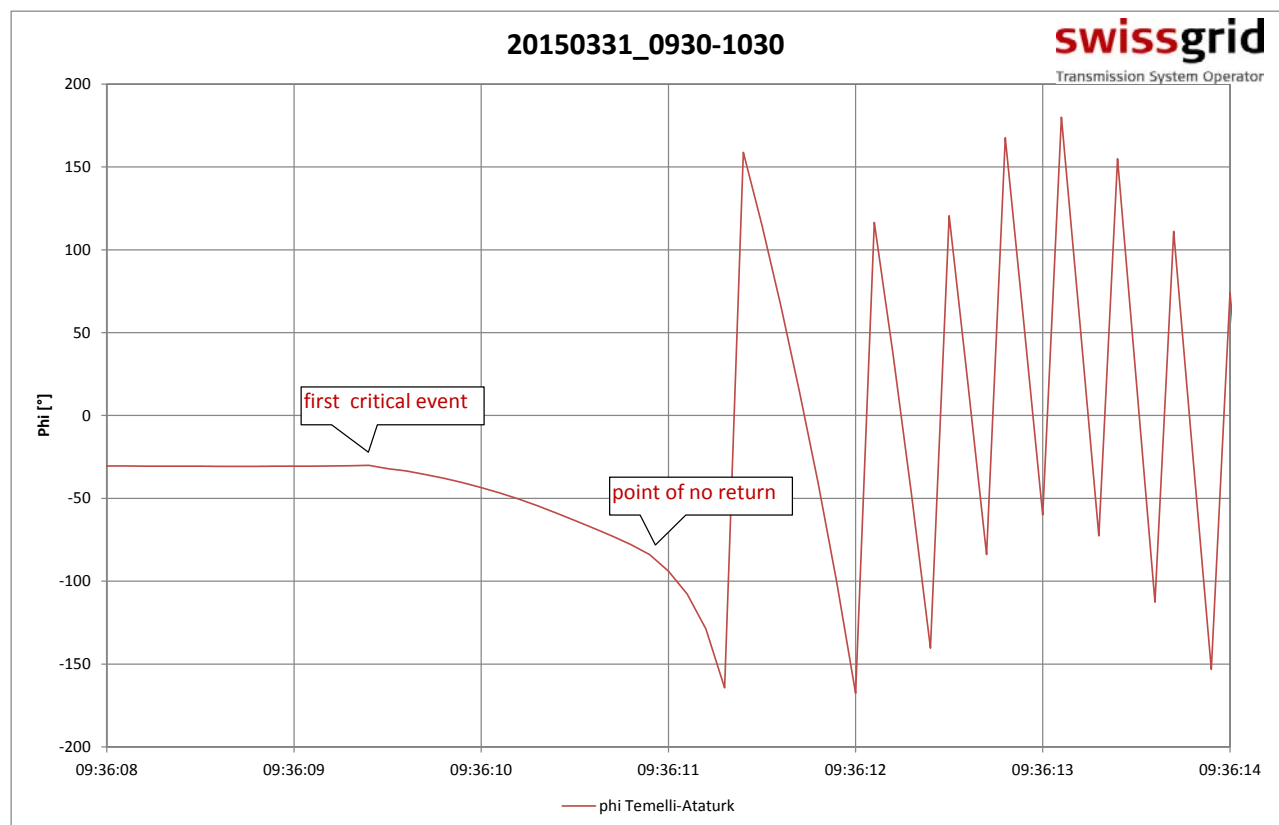
With the help of the existing WAM measurements, see Figure 6, a final model check and fine-tuning was possible.

Figure 6: Voltage phase angle difference during angular instability

In Figure 6 the angular displacement between the main generation area (Atatürk) and the main consumption area (Temelli) is shown with focus on the time between the opening of the first line (first critical event) and the second line after 1.6 seconds (point of no return).

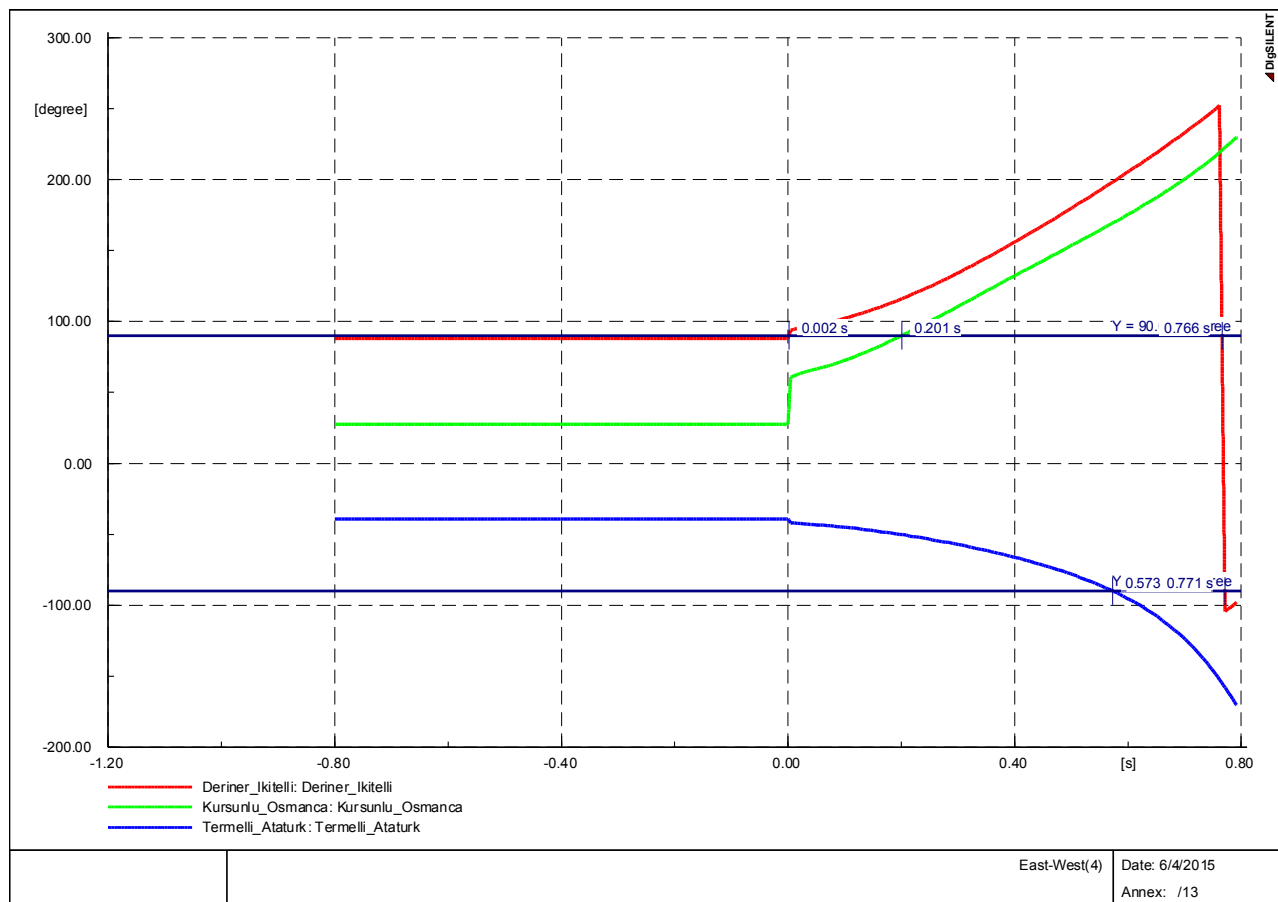
The simulation results of this dynamic behaviour are represented in Figure 7; it is worth while noting that angle differences before the first line tripping are in proximity of the static stability limit (blue horizontal lines). That means that after the first line separation the stability of the Turkish system was lost as the voltage phase difference between the two substations one of the Eastern and one of the Western areas reflects the resulting asynchronous operation of both areas.

Figure 7: Dynamic model simulation results for angular instability process

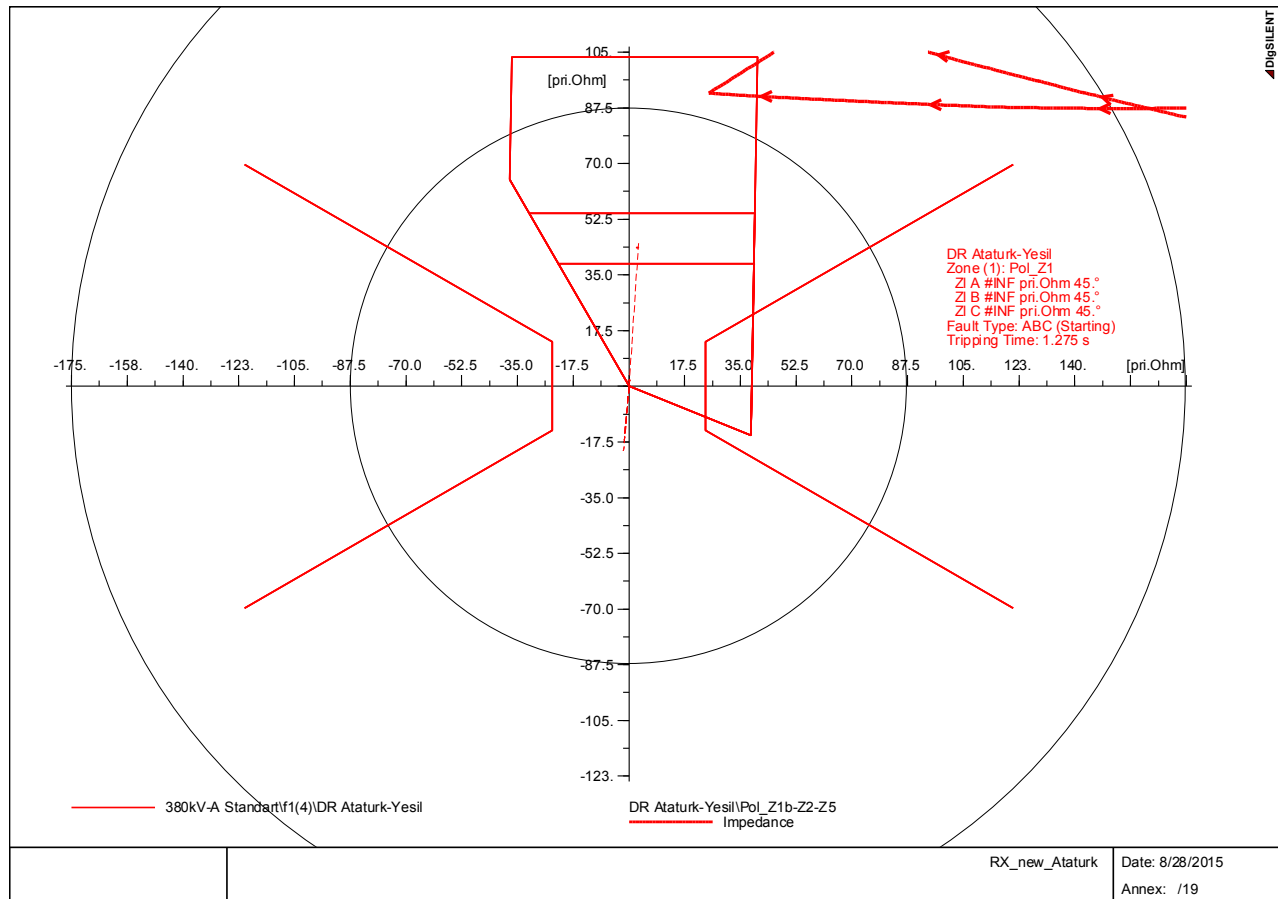
Figure 8: Simulation of distance protection triggering scheme for Atatürk-Yesilhisar North line

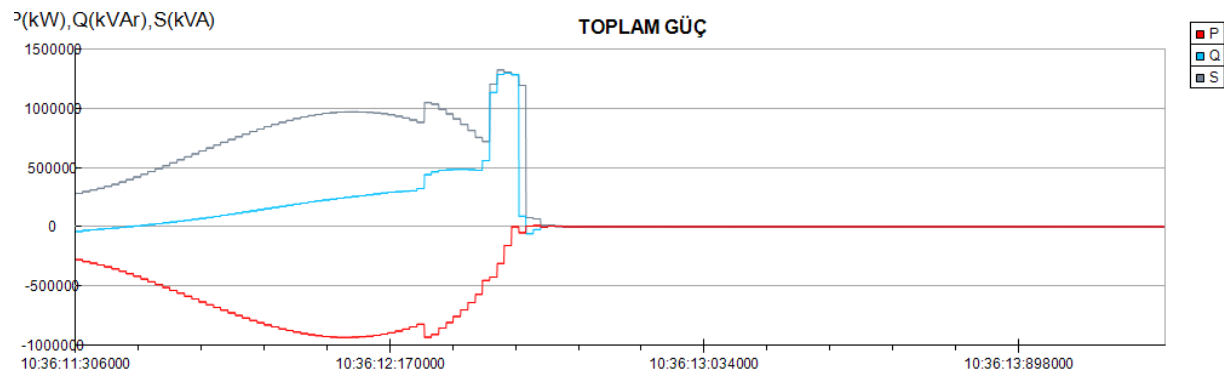
As shown below in Figures 9 to 11, Turkey was isolated from ENTSO-E Grid by activation of protections on the Bulgarian and Greek side. Owing to the exceedingly large deficit of generation in Turkey, which caused loss of synchronism with the CE system, the SPS did not have the capacity to prevent the separation of the Turkish system.

Figure 9: Hamitabat (TR) - Maritsa East 3 (BG) line-1, EET time stamps

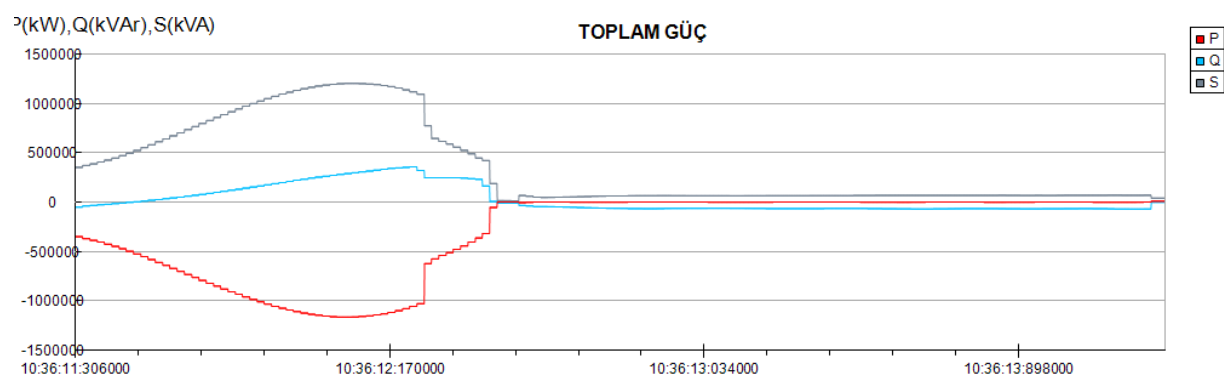
Figure 10: Hamitabat (TR) - Maritsa East 3 (BG) line-2, EET time stamps

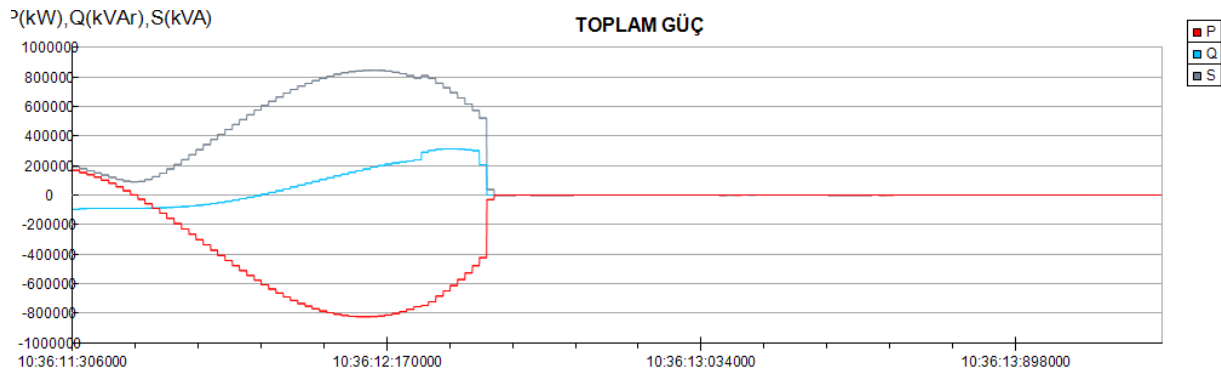
Figure 11: Babaeski (TR)-Nea Santa (GR) line, EET time stamps

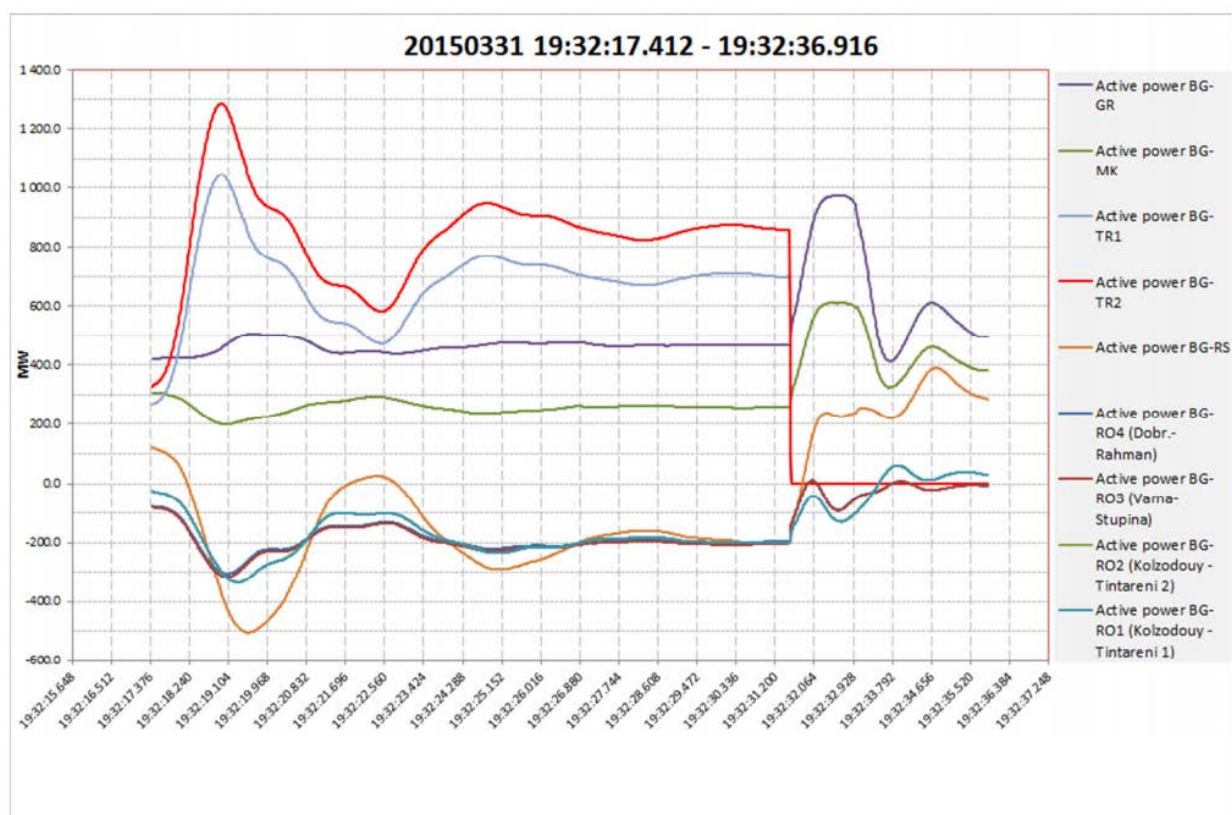
Recordings from the second disturbance which occurred during the restoration at 18:32:17 (CET) is shown on the next two figures (Figure 12 and Figure 13). Only the overloading protections reacted – 1400 MW/8 s which tripped the two interconnection lines between Bulgaria and Turkey. The summary peak value of the active power over BG-TR lines 1&2 was 2332 MW. The Hamitabat SPS dP/dt and P pick-up thresholds were exceeded for the disconnection of all the 3 blocks of load, and also the SPS 1300 MW – 3.5 sec. overload threshold were exceeded, but the load shedding was not activated for reasons that have not been reliably identified.

Figure 12: Disconnection of TR power system after the end of the restoration process, EET time stamps

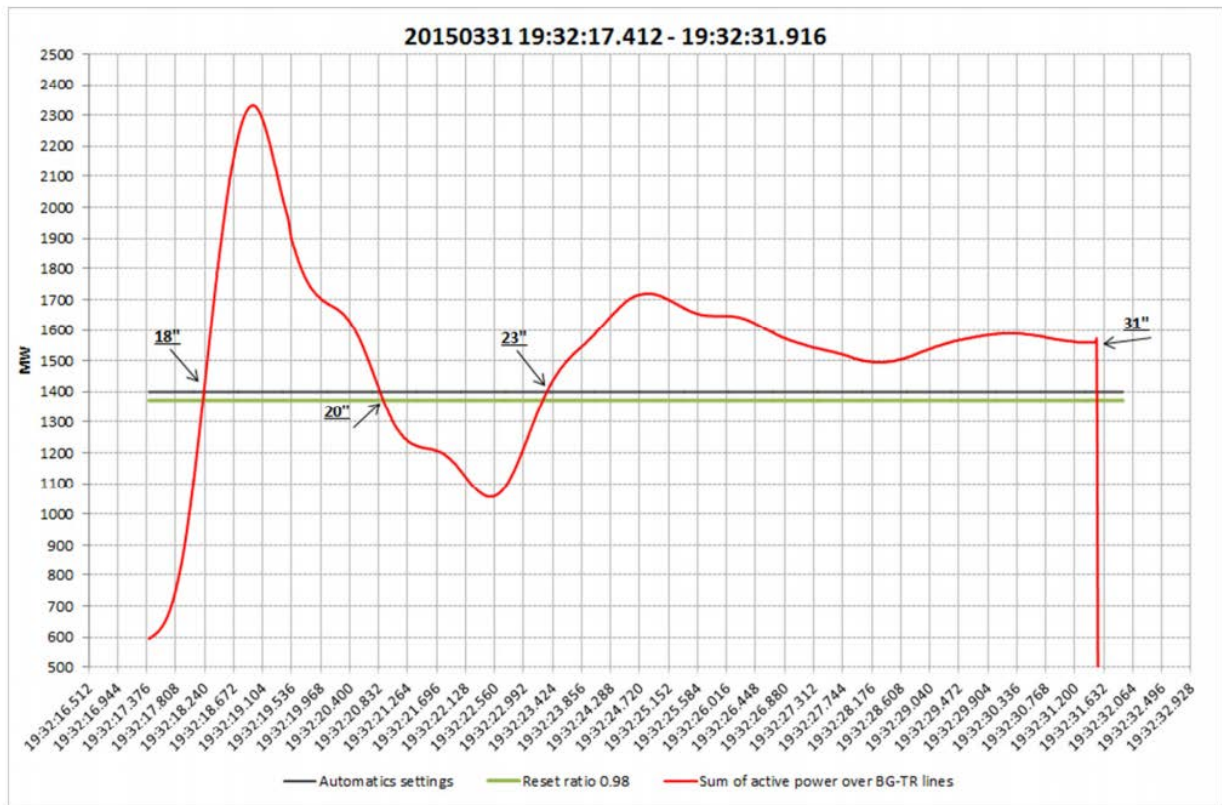
Figure 13: Overload protection activation during TR system separation, EET time stamps; summary flow over BG-TR lines 1&2

During the first and second disturbance active and reactive power swings of generators in the whole of the Bulgarian grid were observed. The deviation of the machines in TPP ME3 was around 135 MW (rated active power 227 MW).

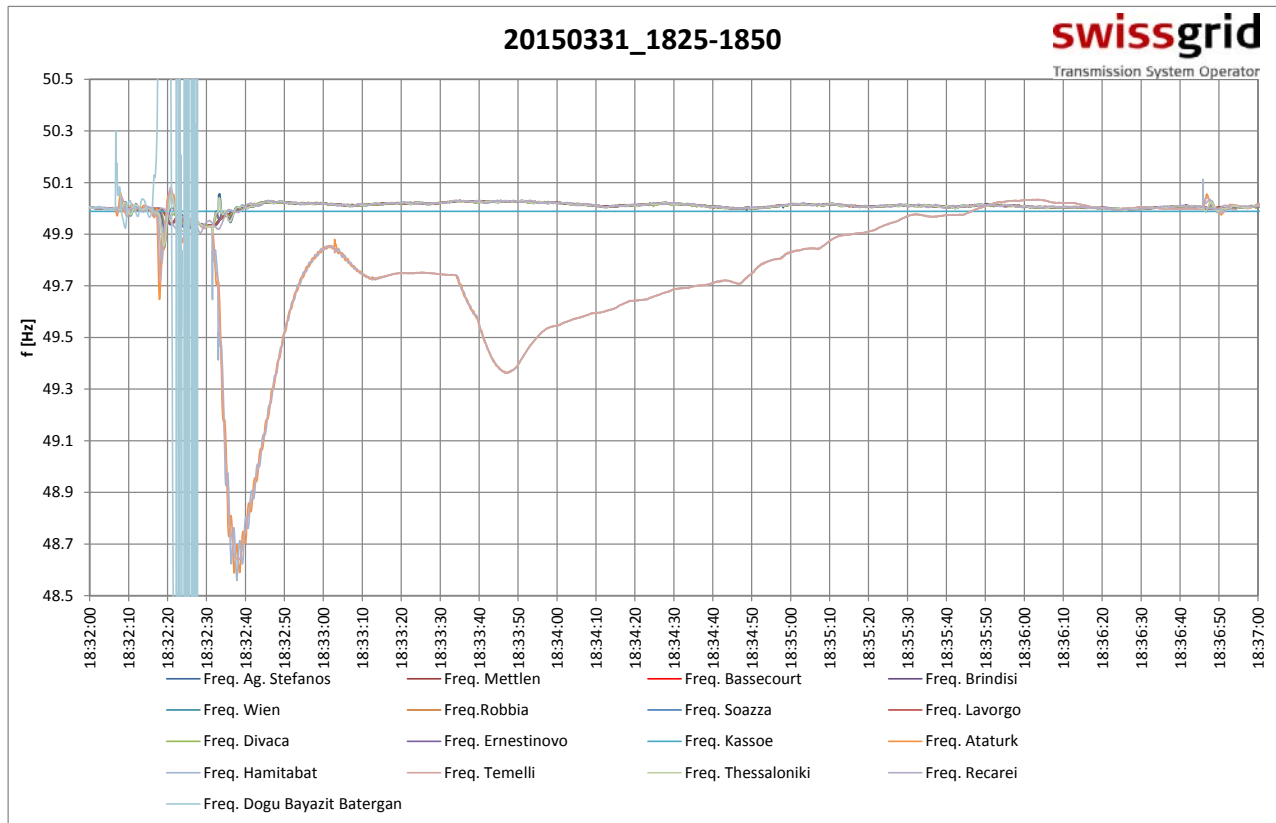
The system frequencies during the TR evening island operation are shown in Figure 14.

Figure 14: Frequencies during evening TR island system operation, CET time stamps

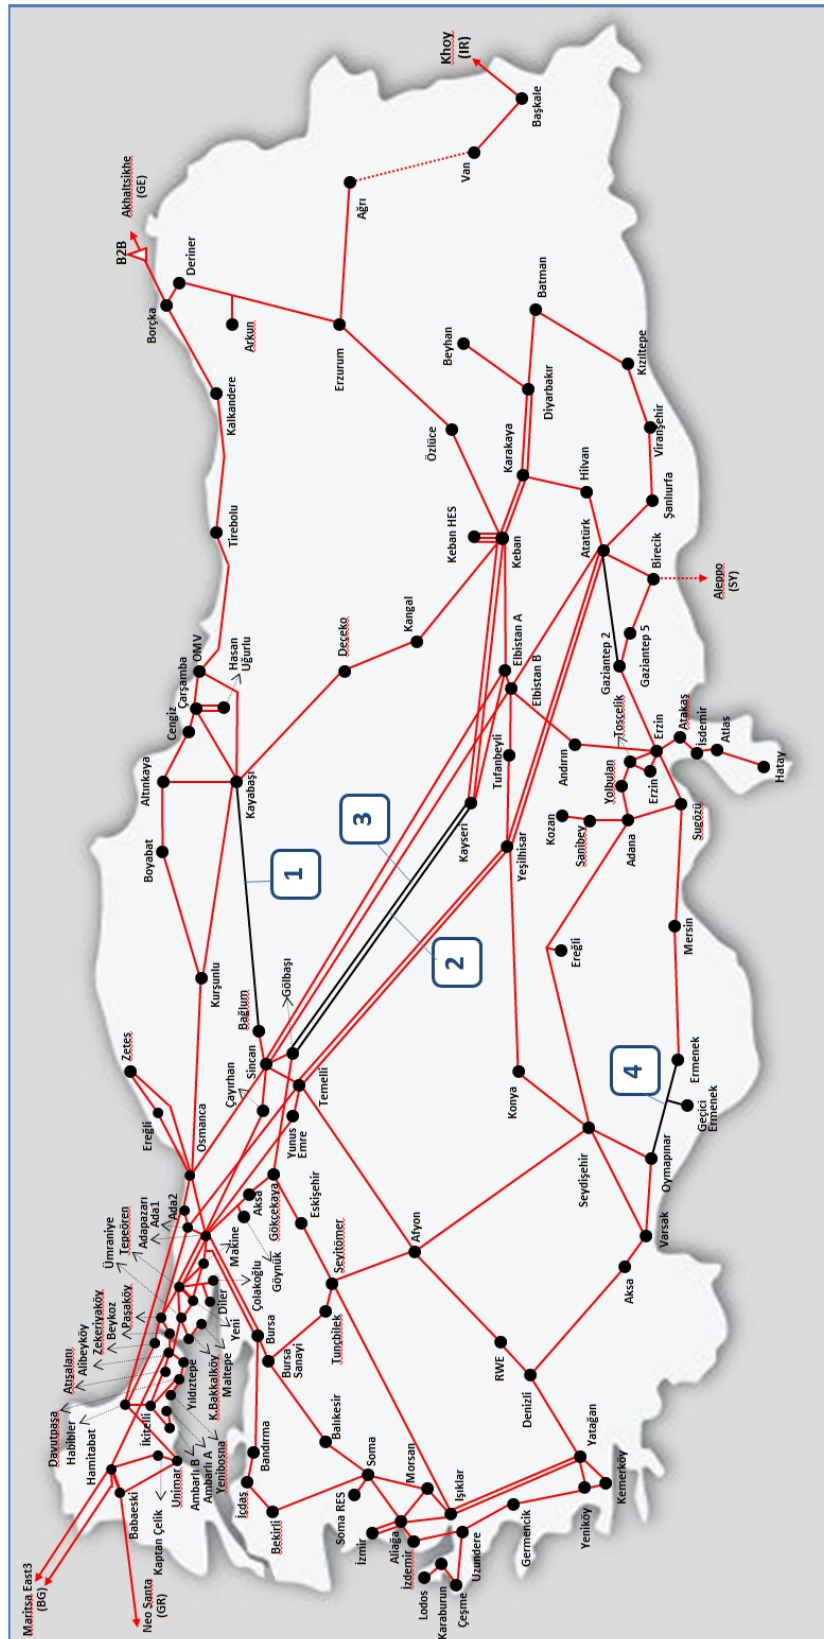
Appendix- 1: Situation before the disturbance

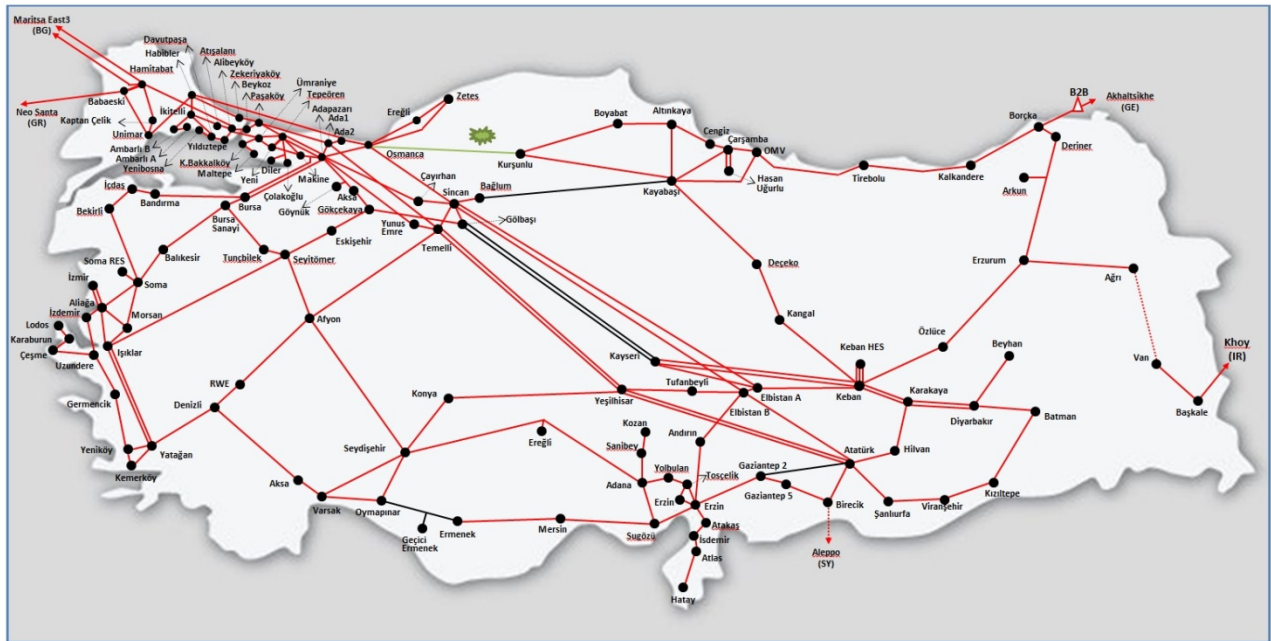
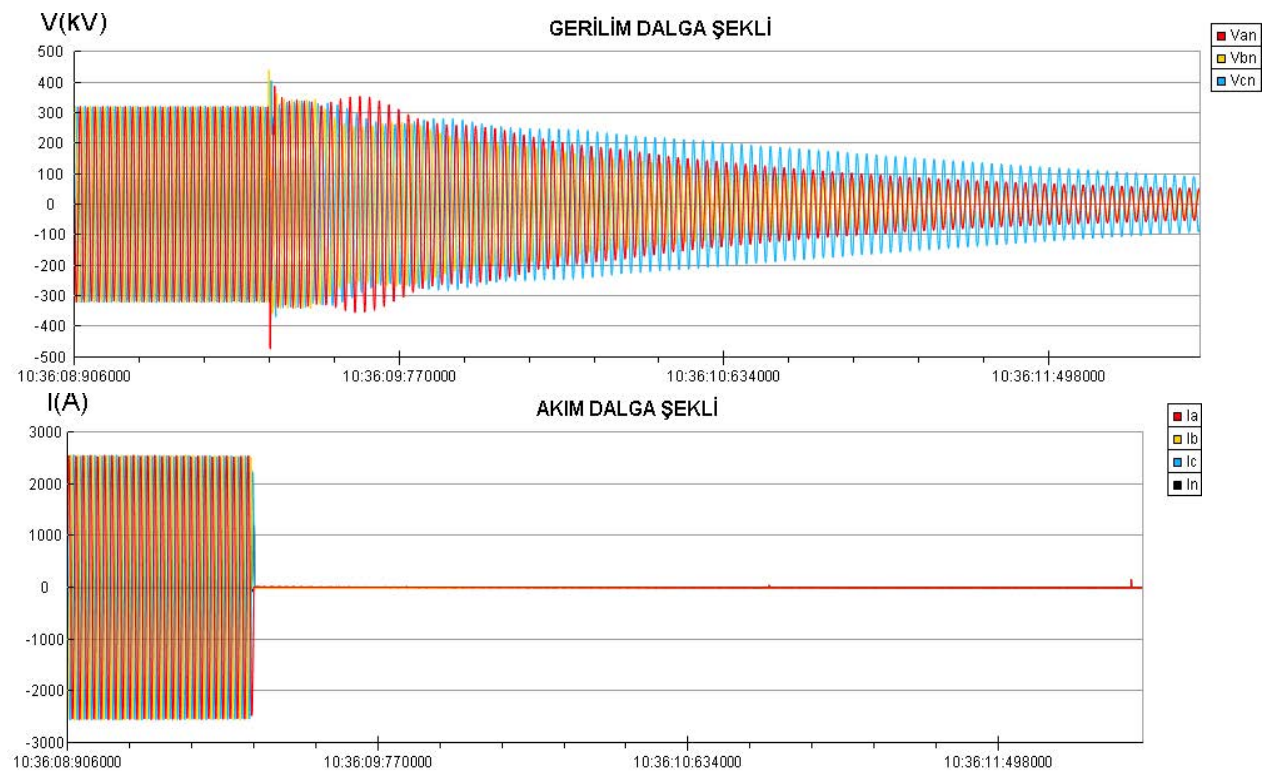
Appendix- 2: Opening of Kursunlu-Osmanca 400 kV TL

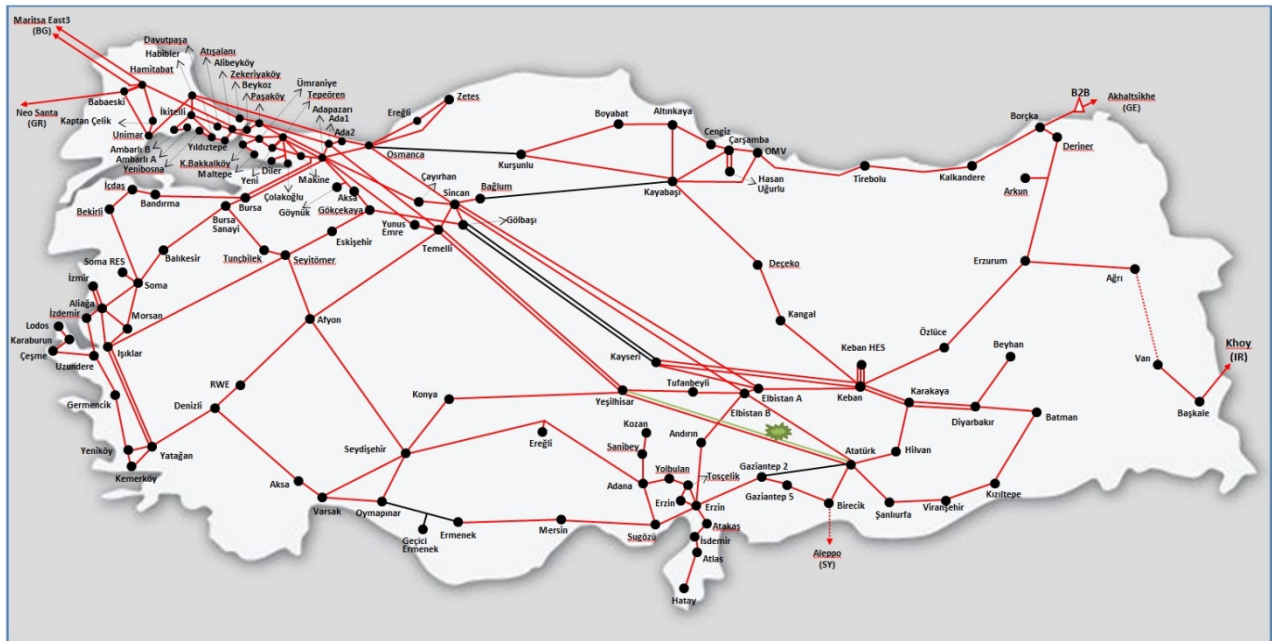
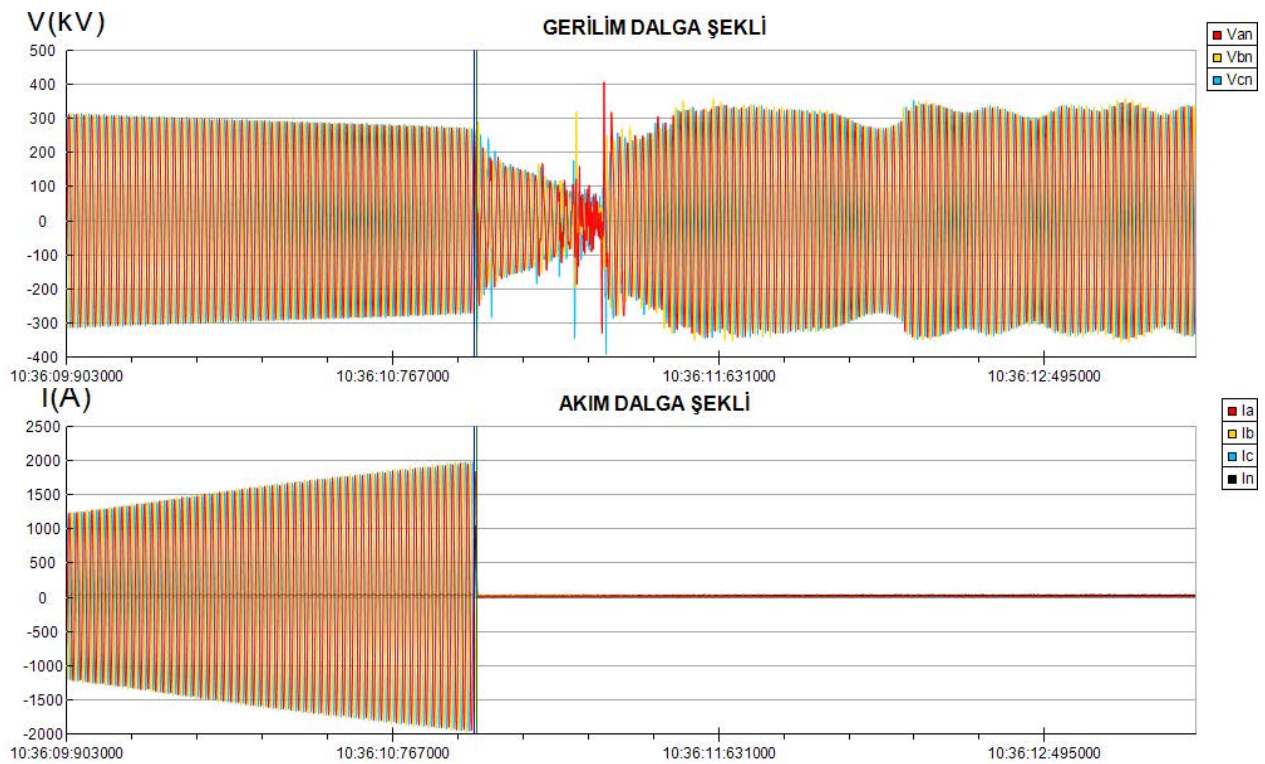
Appendix- 3: Opening of Ataturk-Yesilhisar Kuzey (North) 400 kV TL

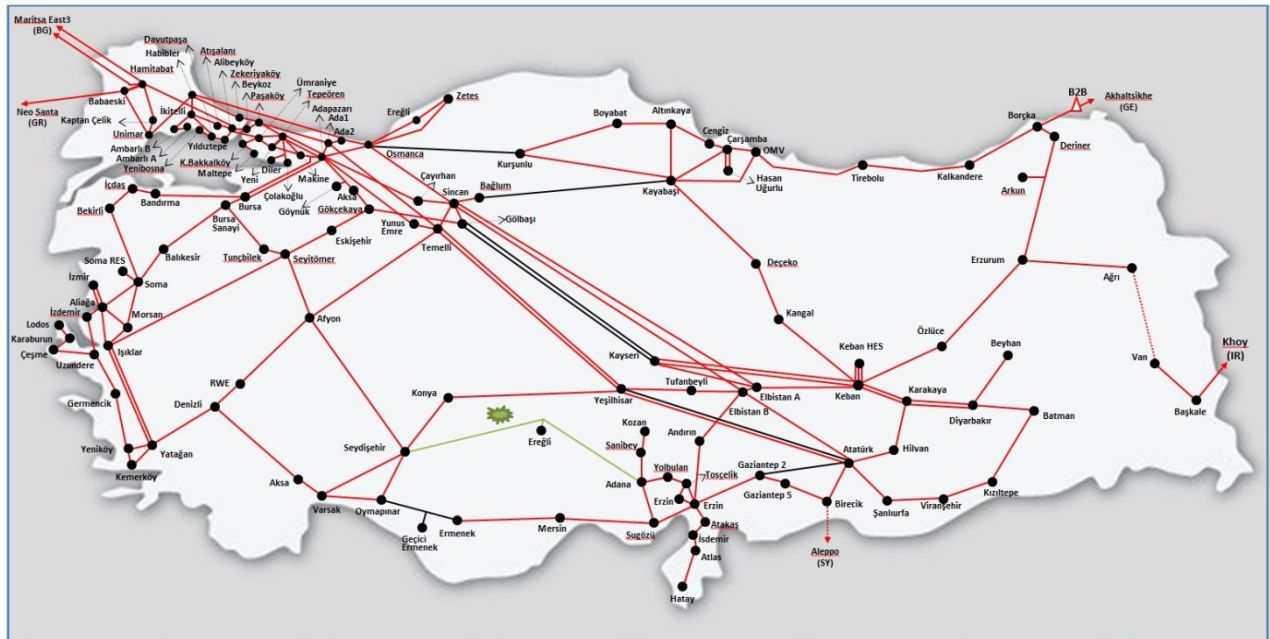
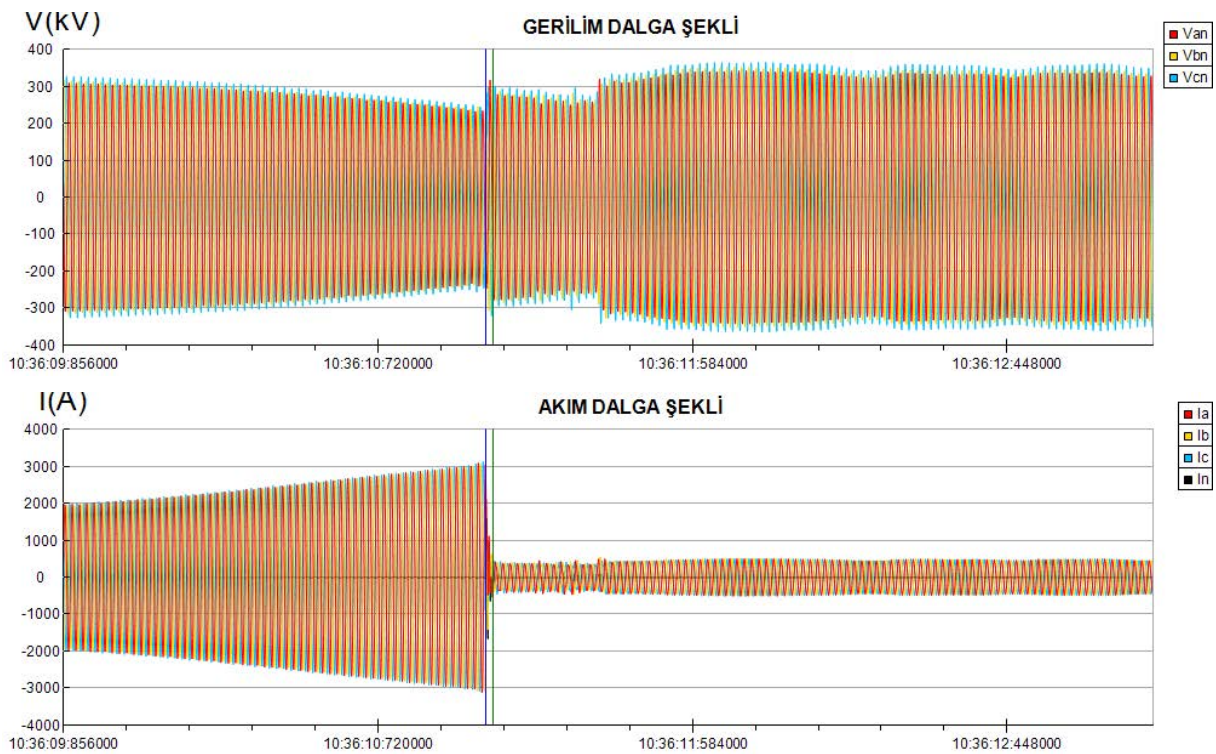
Appendix- 4: Opening of Seydisehir-Adana 400 kV TL

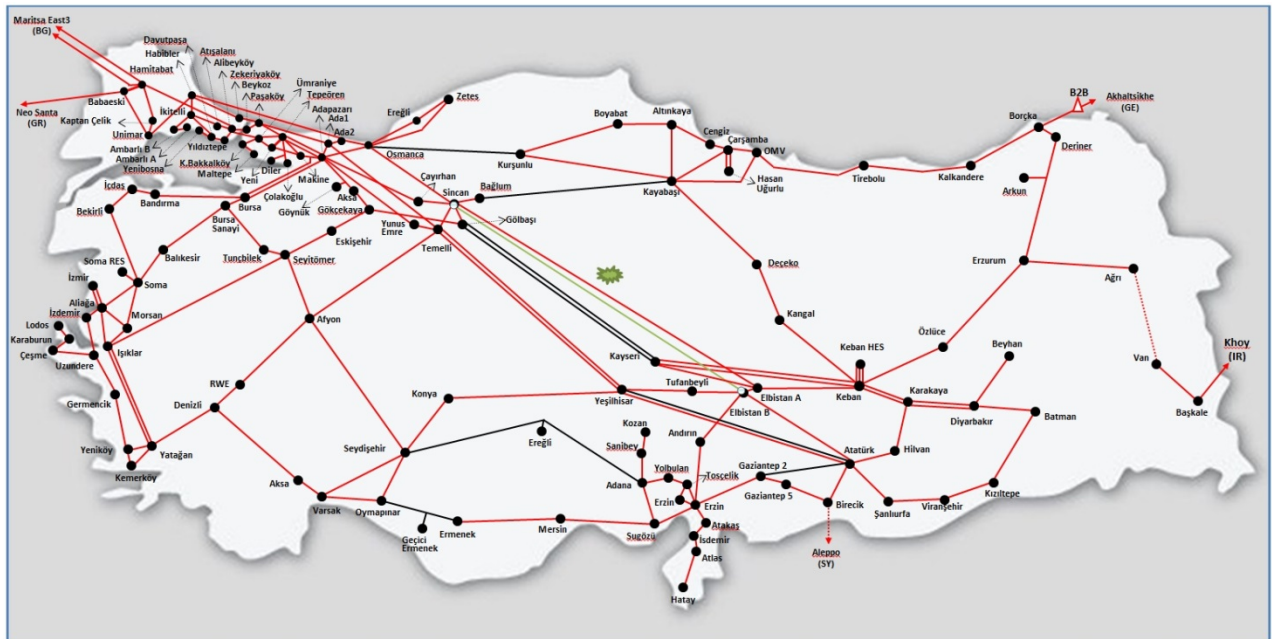
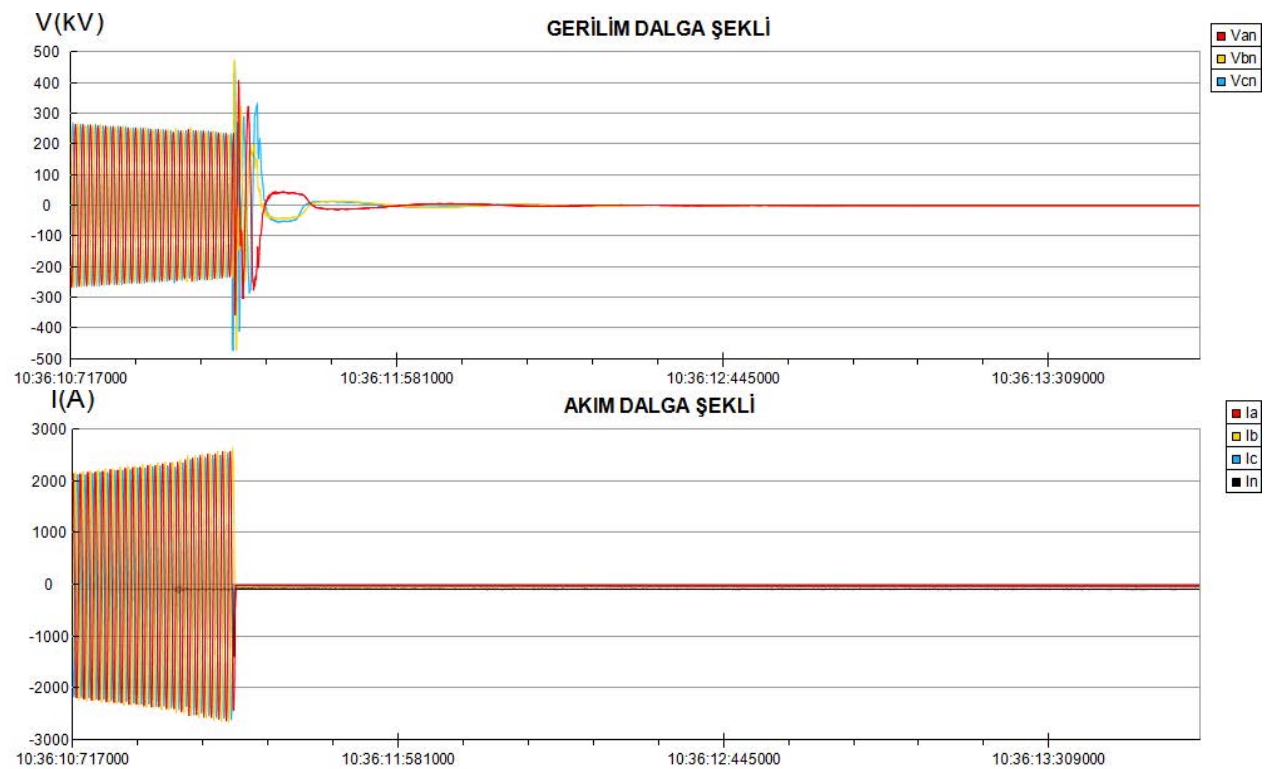
Appendix- 5: Opening of Sincan-Elbistan B 400 kV TL
