Report on Blackout in Turkey on 31st March 2015

– Final Version 1.0 –

Project Group Turkey

21 September 2015

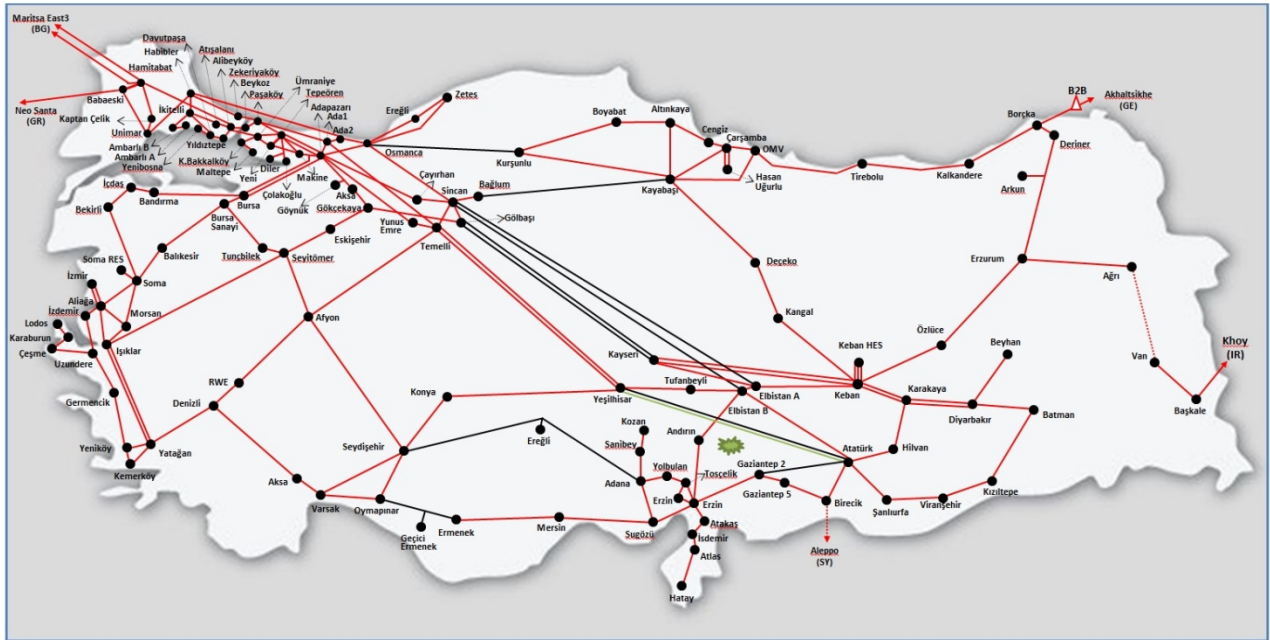
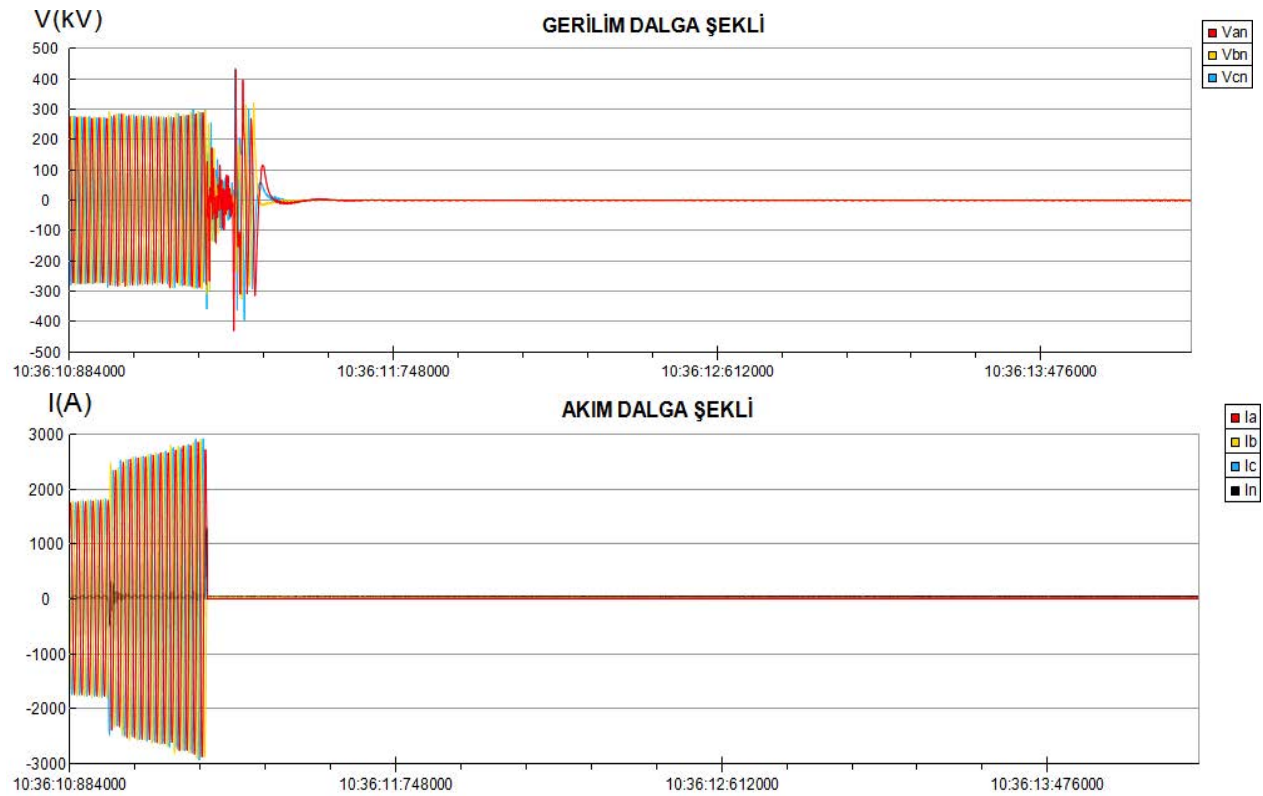
Appendix- 7: Opening of Ataturk-Yesilhisar Guney (South) 400 kV TL

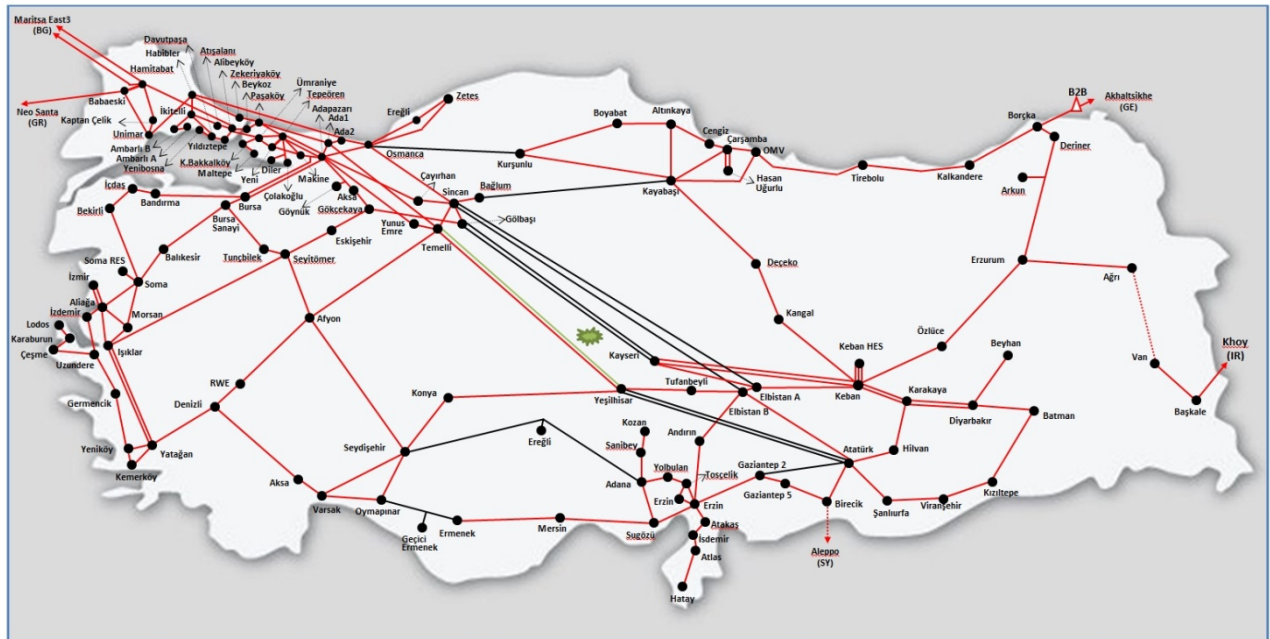
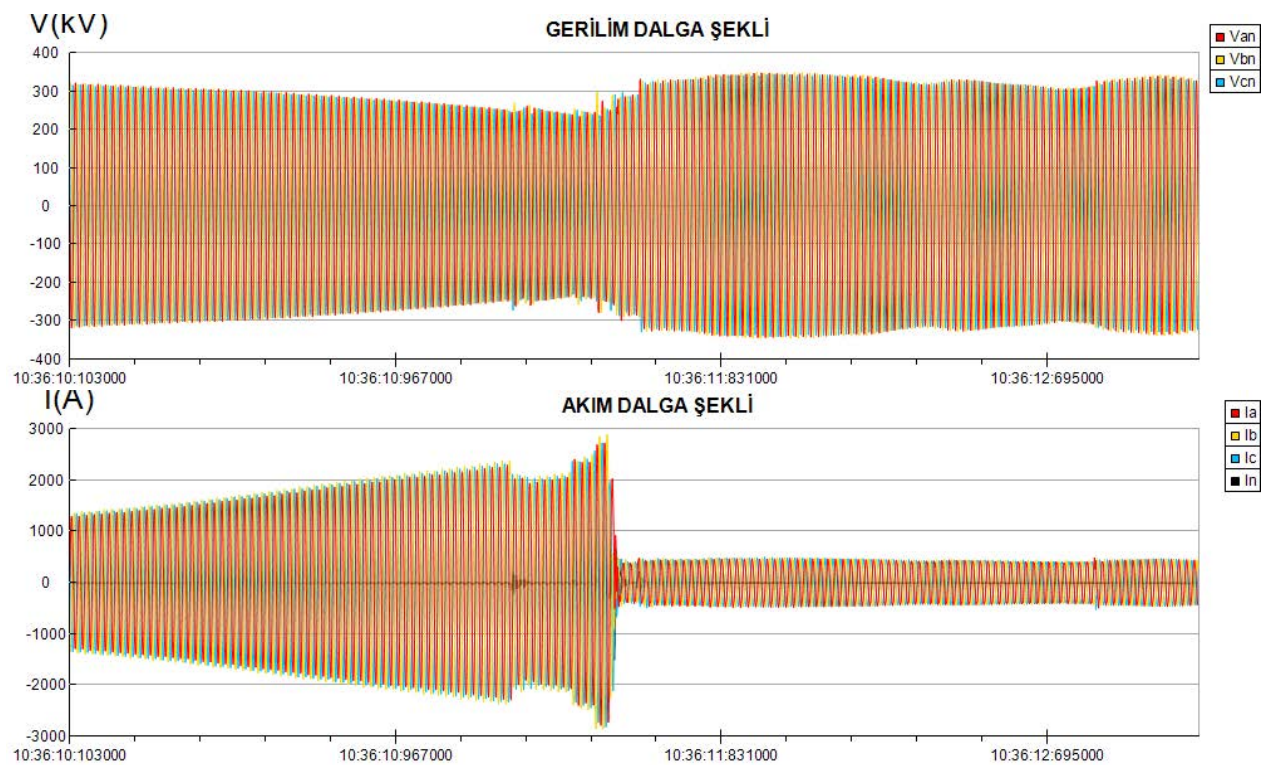
Appendix- 8: Opening of Temelli-Yesilhisar Kuzey (North) 400 kV TL

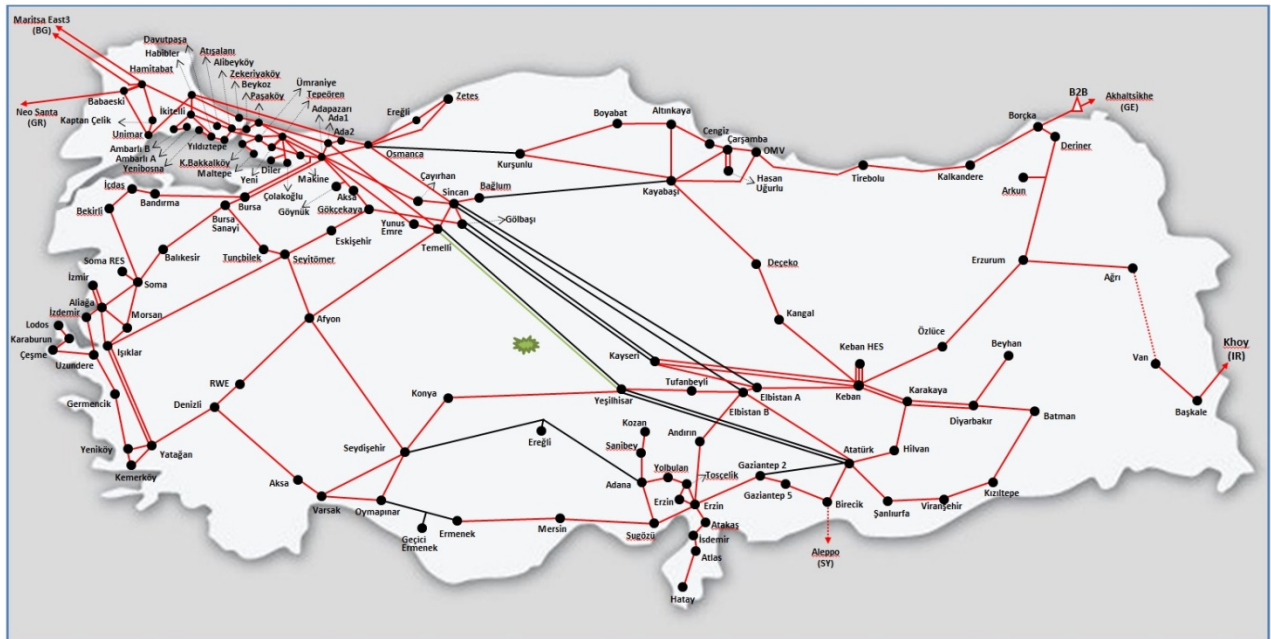
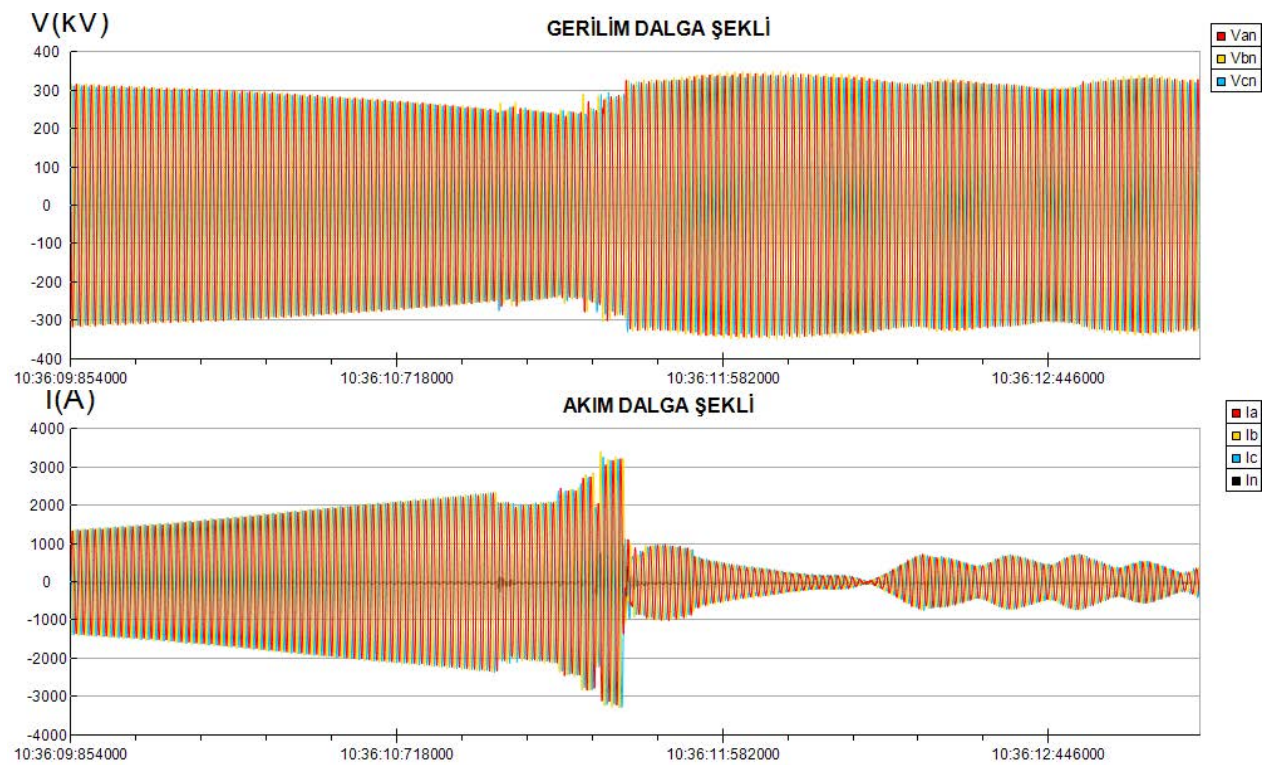
Appendix- 9: Opening of Temelli-Yesilhisar Guney (South) 400 kV TL

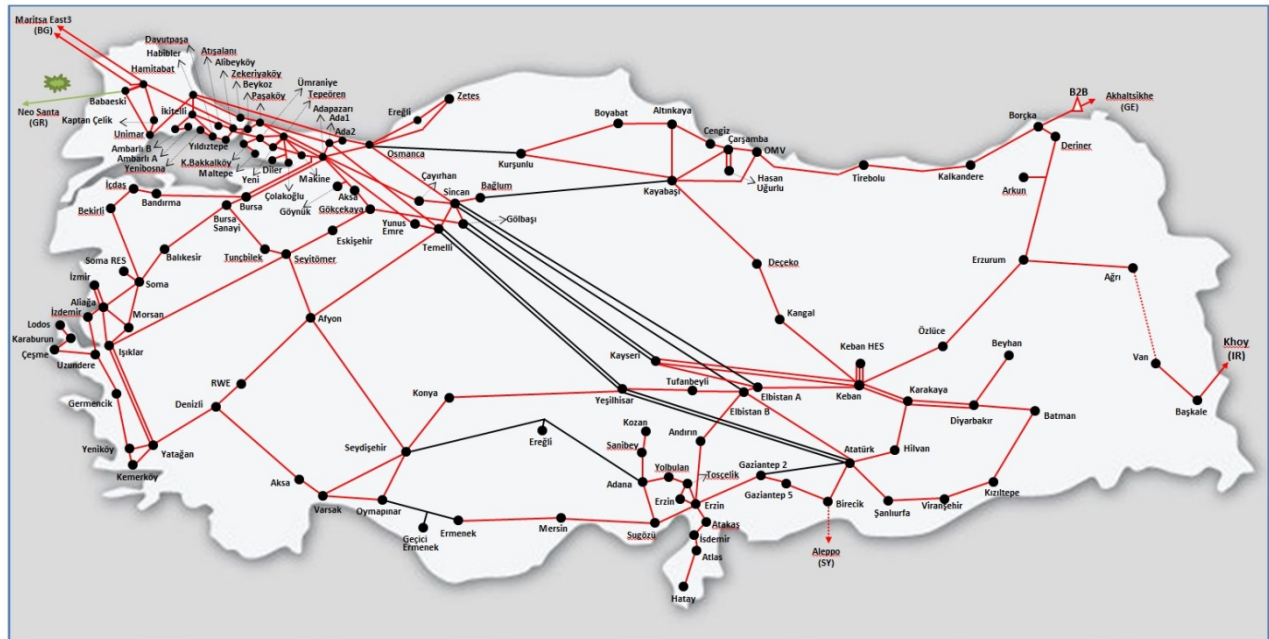
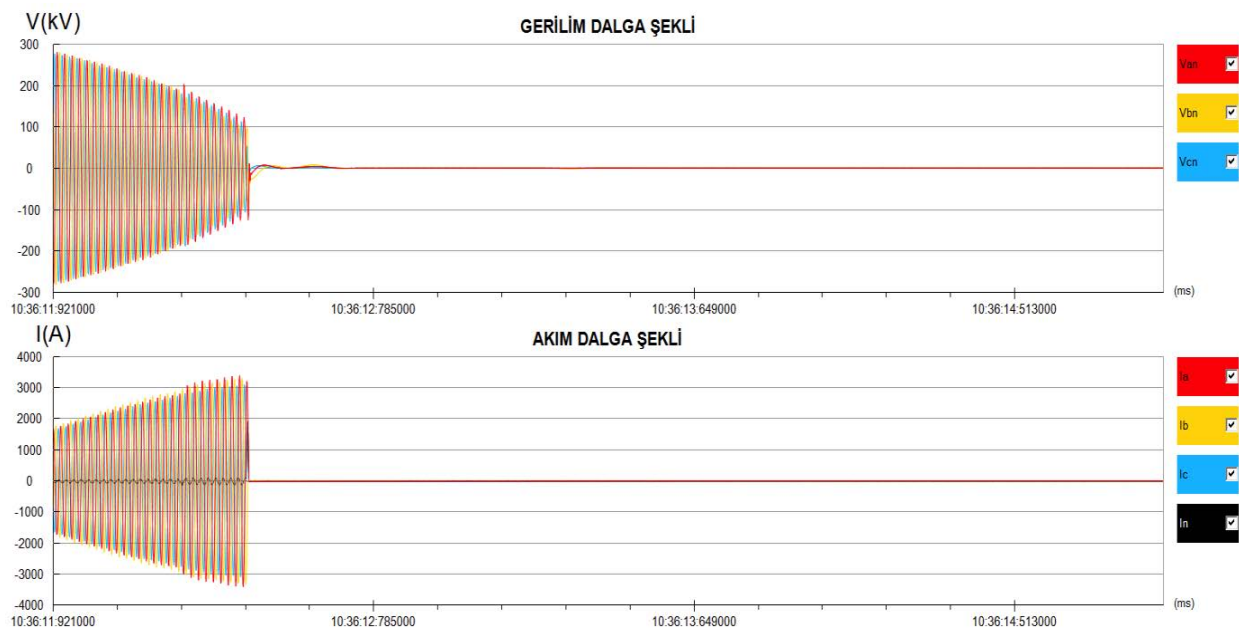
Appendix- 10: Opening of Babaeski (TR) – Nea Santa (GR) 400 kV TL

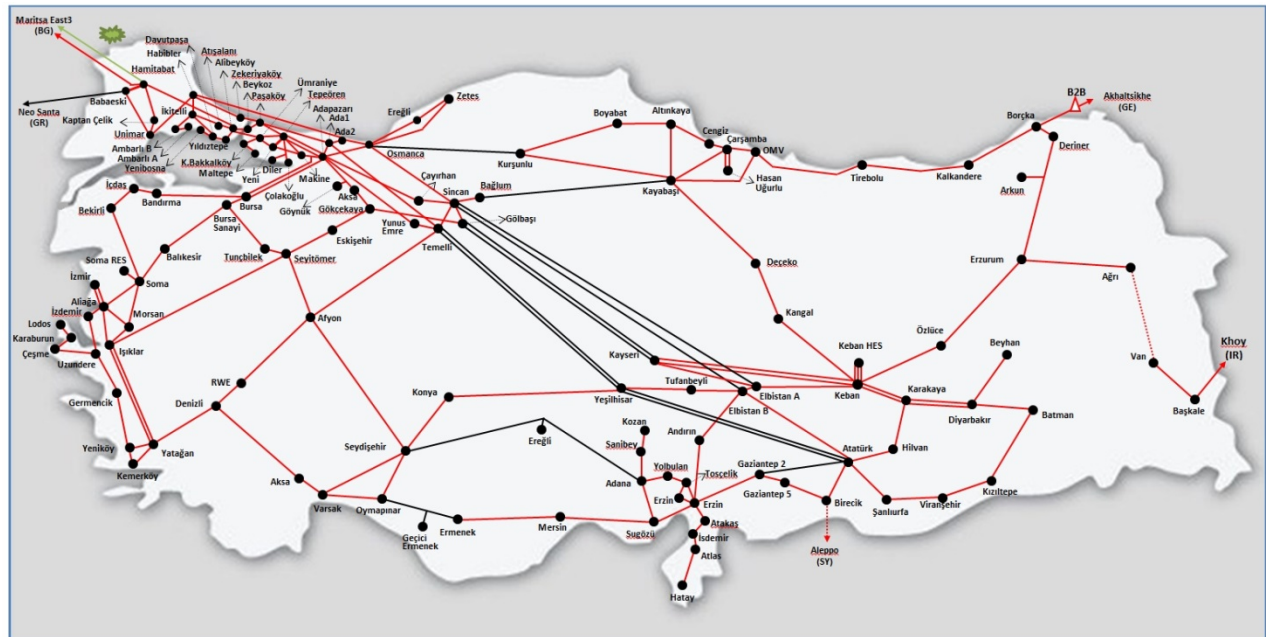
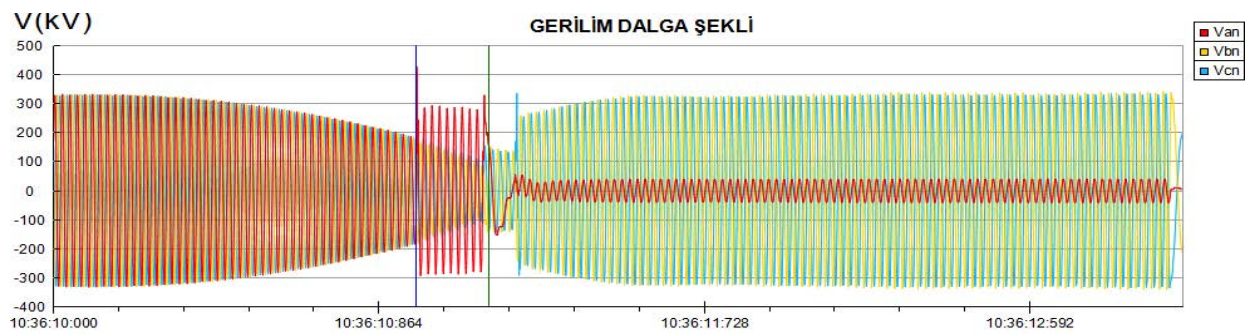
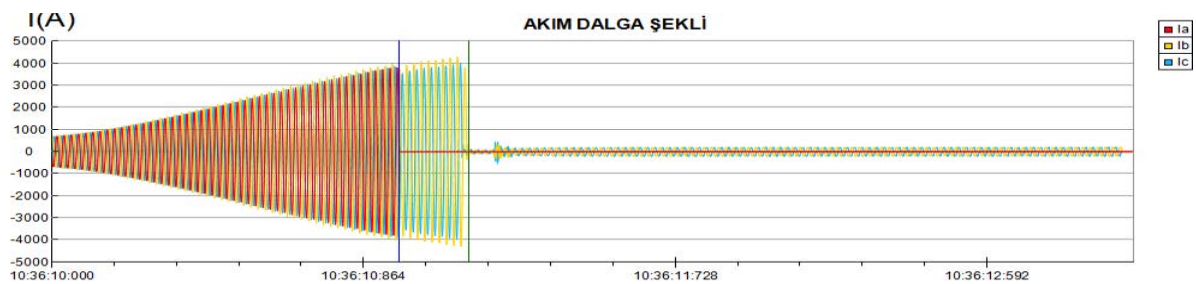
At 09:36:12:267, circuit breaker of Hamitabat (TR)-Maritsa East 3 (BG) interconnection line 2 (in Hamitabat SS) opened the Phase A contact. According to the findings from the relay records, this opening was caused by wrong contact assignment. At 09:36:12:442, Hamitabat (TR)-Maritsa East 3 (BG) interconnection line 2 was tripped due to the activation of “out-of-step” relay protection at Maritsa. This line was loaded at 335 MW (2828 A) prior to the trip (instantaneous values at the tripping moment). This event is illustrated in Appendix-11 together with the high-resolution measurement of the voltage and the current on the line.

Appendix- 11: Opening of Hamitabat (TR) – Maritsa East 3 (BG) line 2 400 kV TL

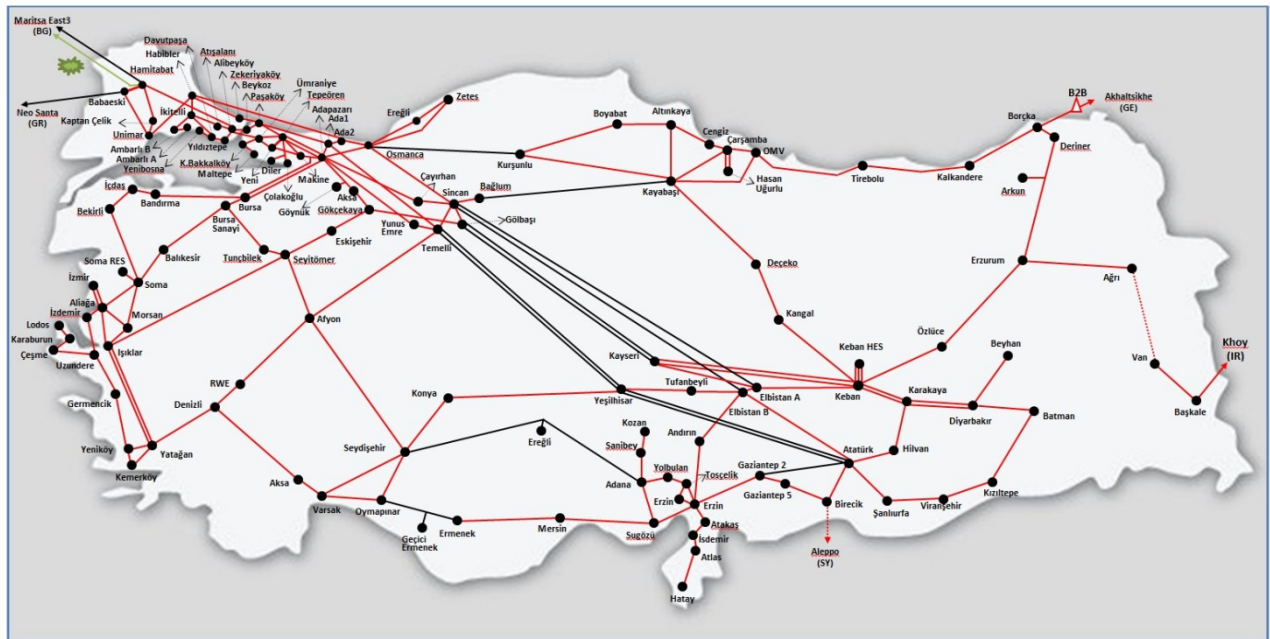
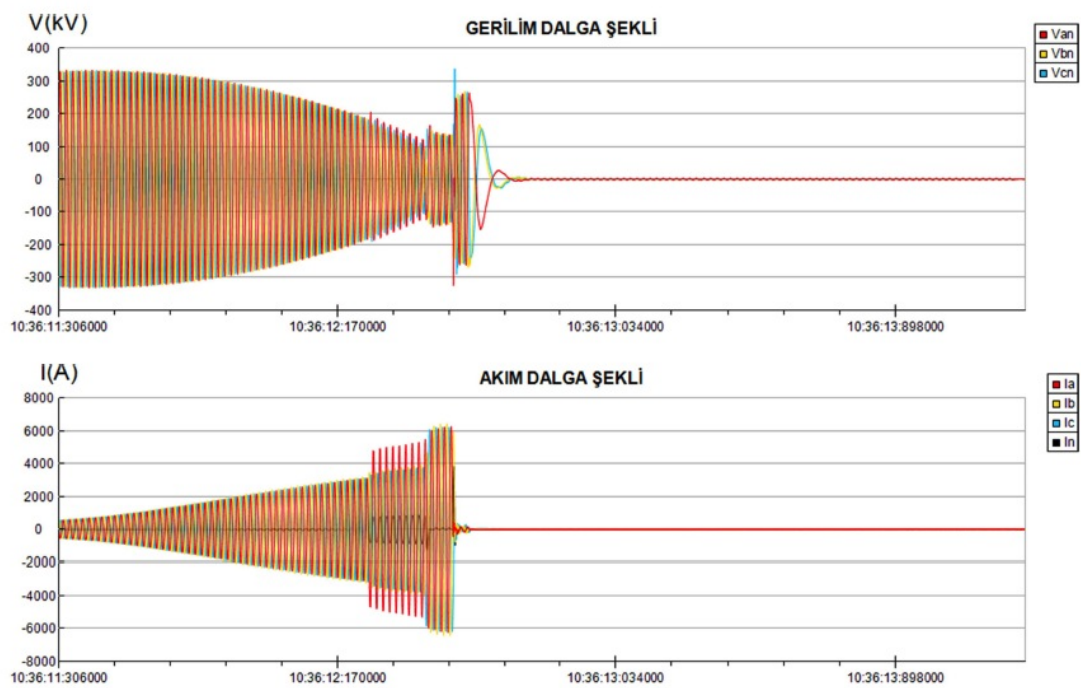
Appendix- 12: Opening of Hamitabat (TR) – Maritsa East 3 (BG) line 1 400 kV TL

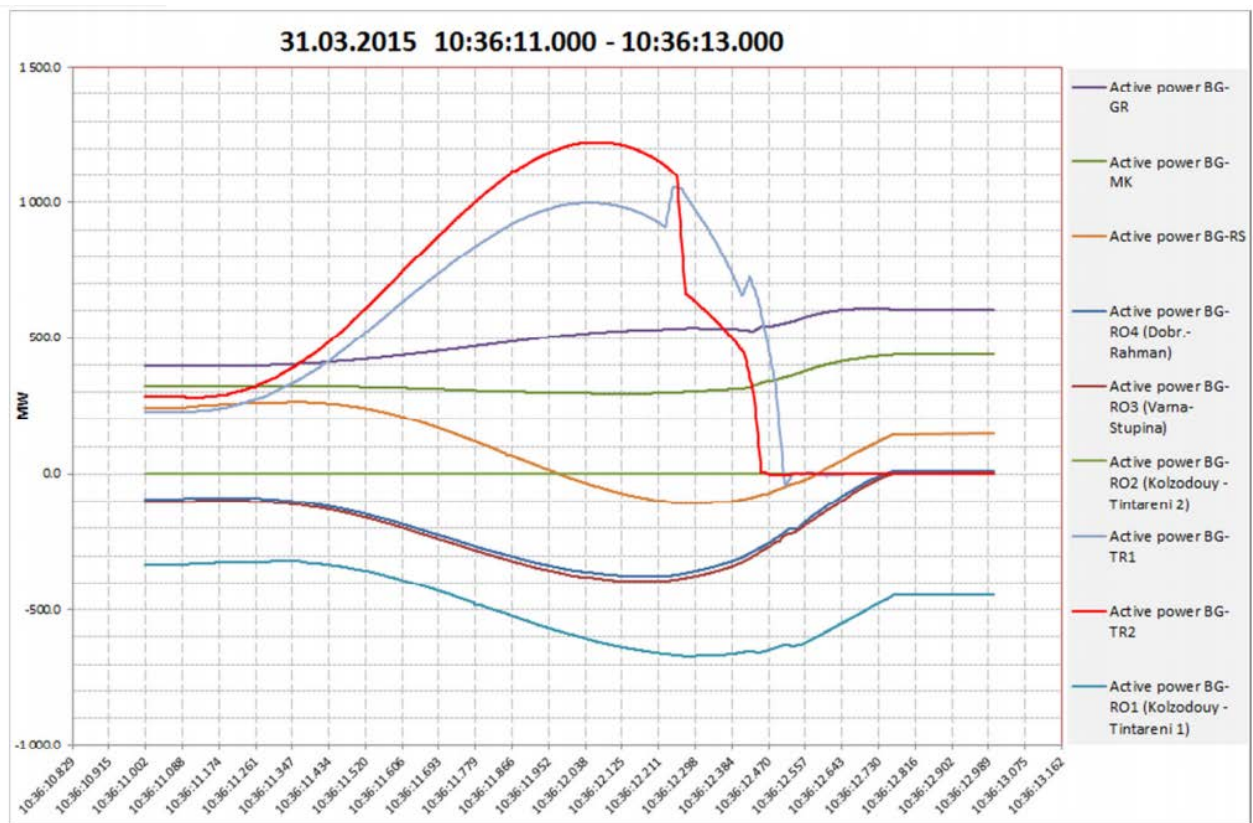
Appendix- 13: Power flow recordings on TR-BG interconnections, EET time stamp

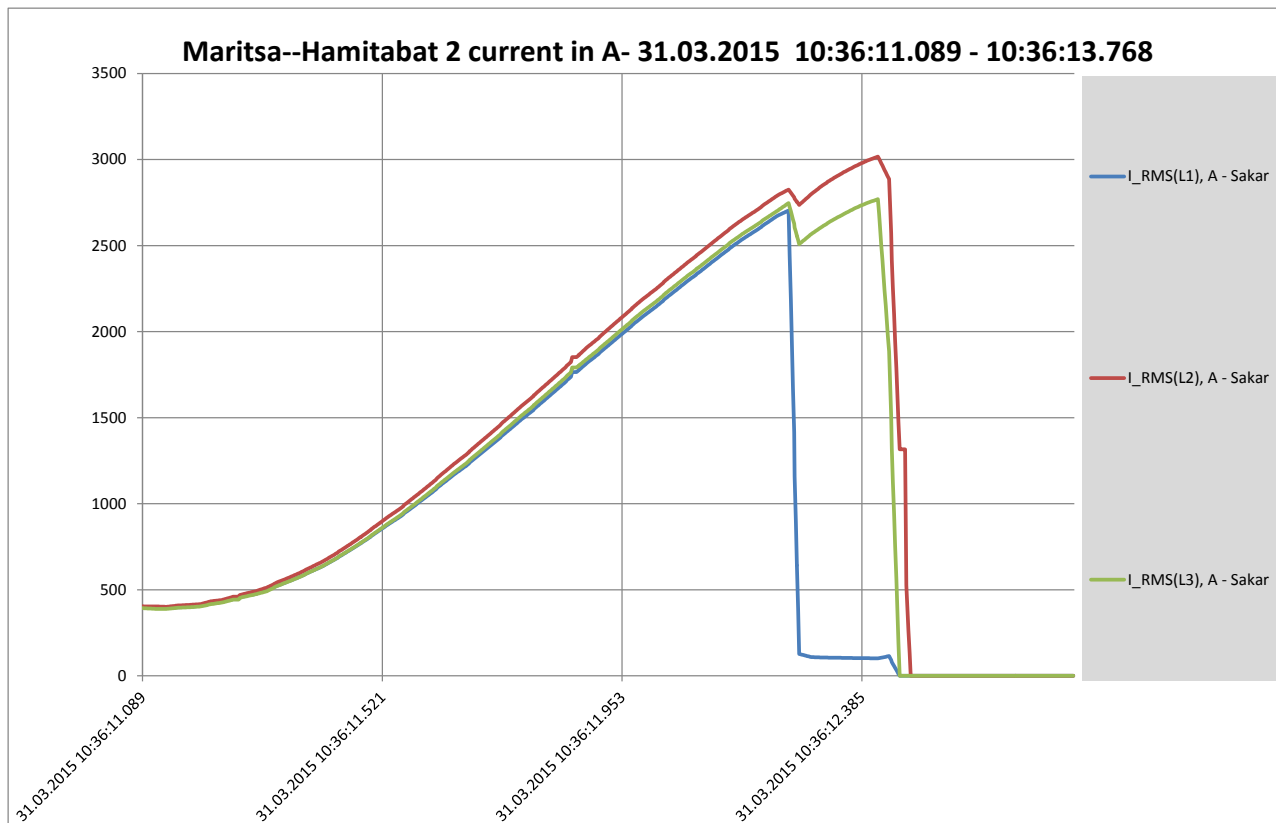
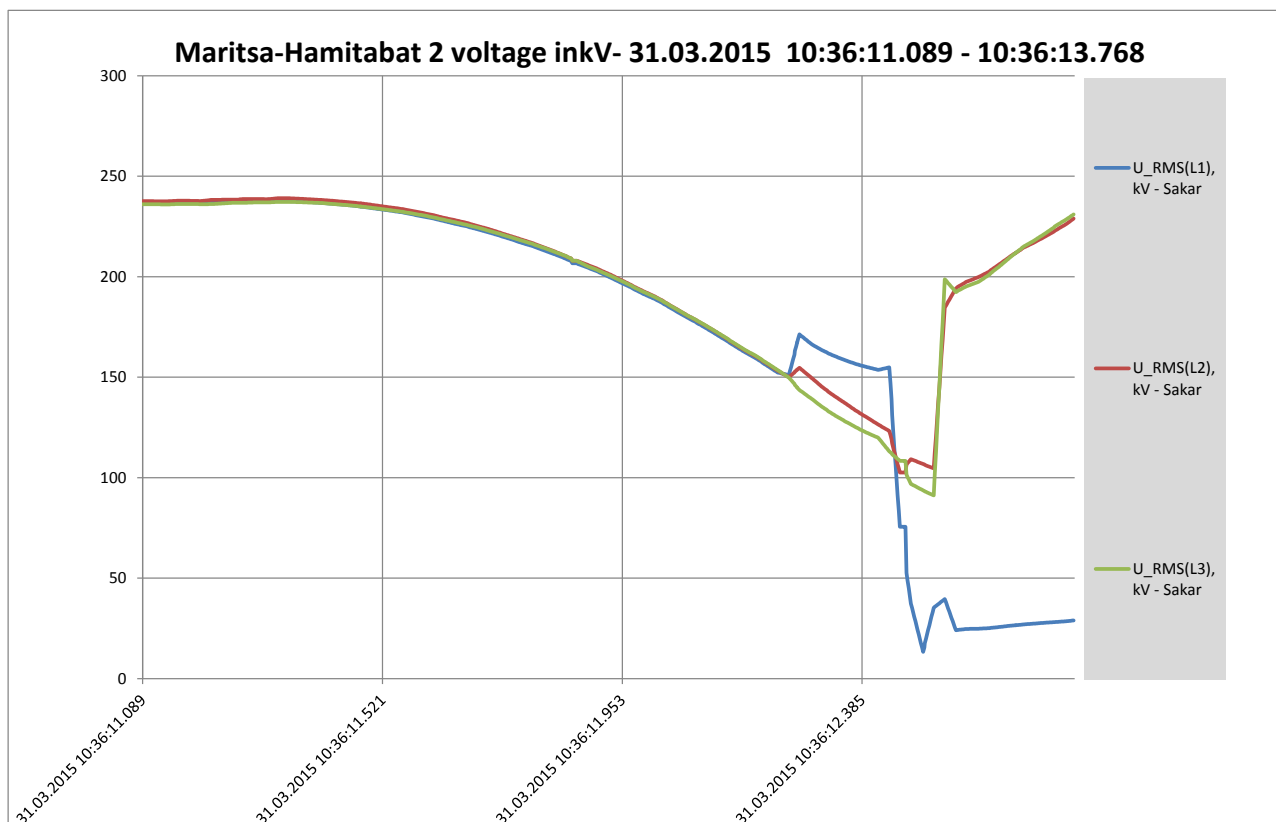
Appendix- 14: Currents and voltages of Maritsa-Hamitabat 2 line, EET time stamp

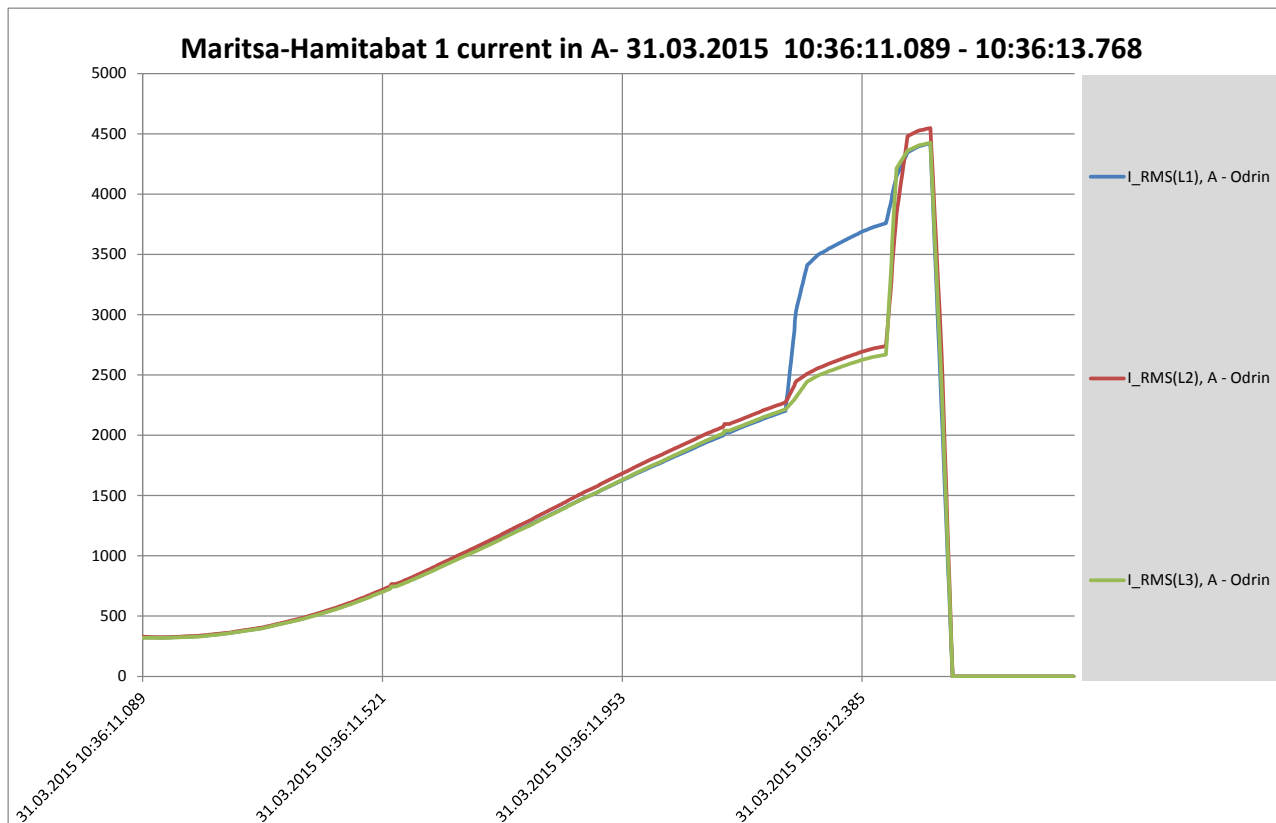
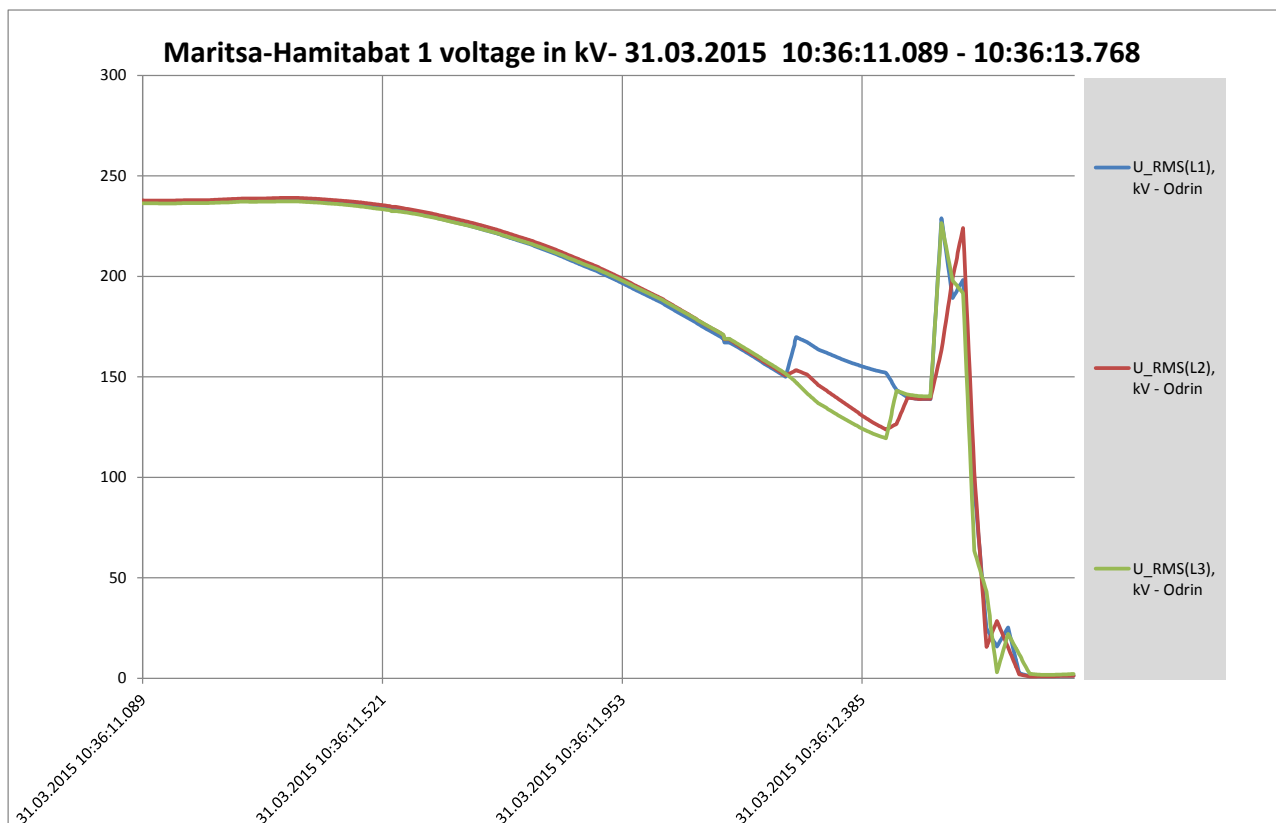
Appendix- 15: Currents and voltages of Maritsa-Hamitabat 1 line, EET time stamp

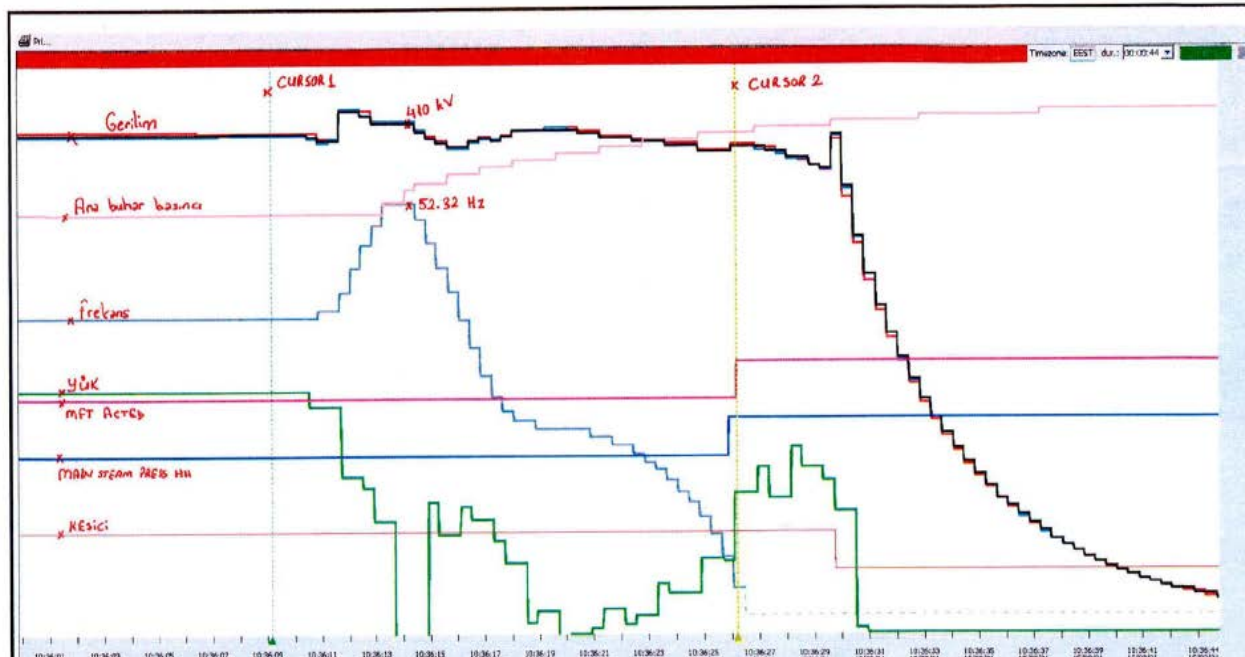
In the graph above:

Black colour (Gerilim) represents the network voltage where PP is connected

Each cell represents 1 seconds, (in total 44 seconds starting from 10:36:00 EET)

Appendix- 17: Power plant SCADA output of Erzin NGCCPP during the blackout

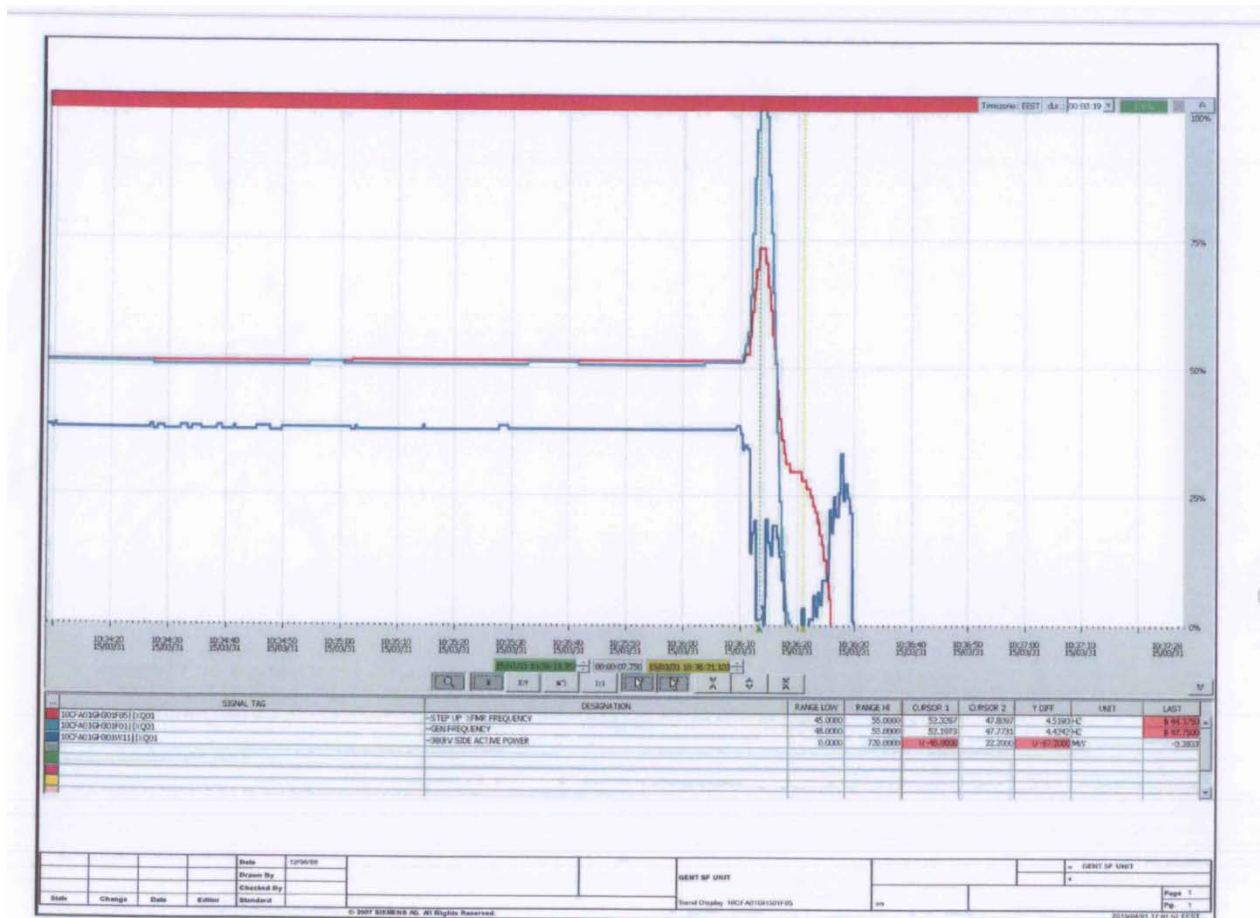
In the graph above:

Red colour represents the network frequency

Each cell represents 10 seconds, (in total 200 seconds)

Appendix- 18: Power plant SCADA output of Atlas TPP during the blackout

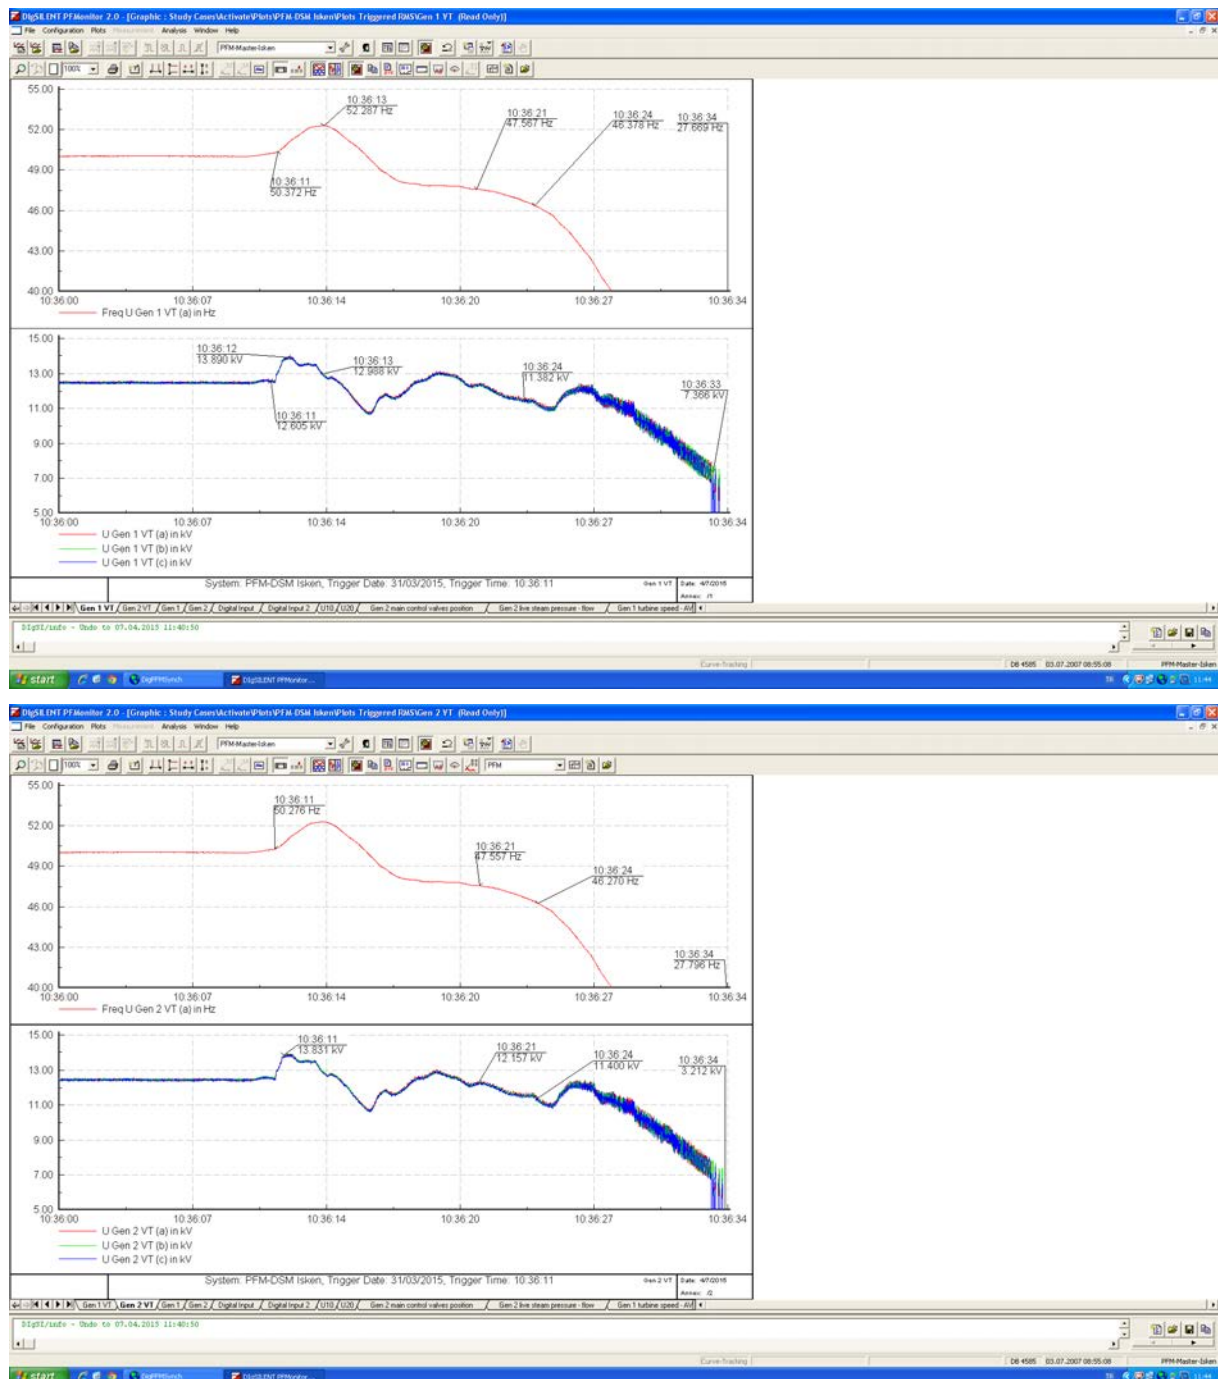
In the graphs above:

Red colour represents the network frequency

Each cell represents 7 seconds, (in total 34 seconds)

Appendix- 19: Power plant SCADA output of Unit 10 and Unit 20 of Sugozi TPP during the blackout

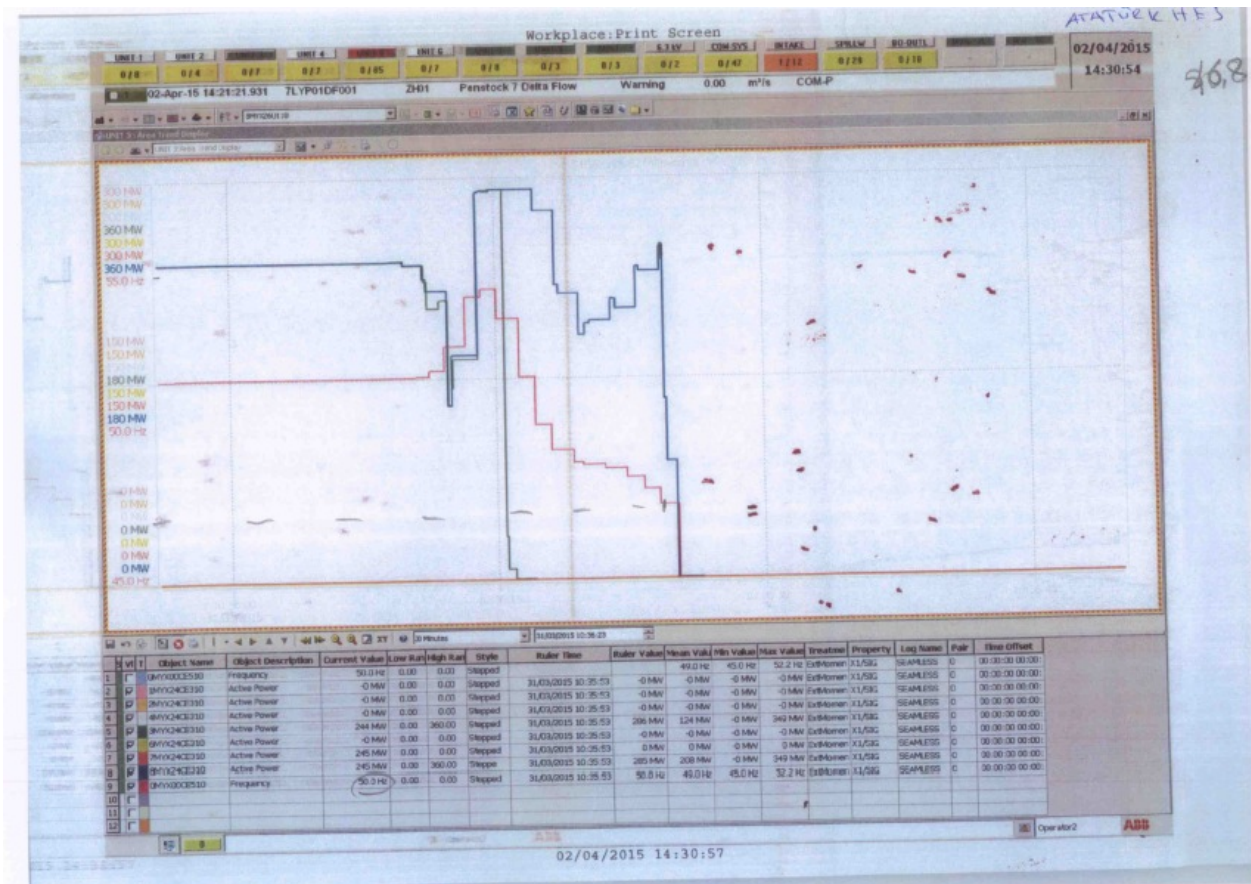
In the graph above:

Red colour represents the network frequency

Each cell represents 20 seconds, (in total 60 seconds)

Appendix- 20 :Power plant SCADA output of Ataturk HPP during the blackout

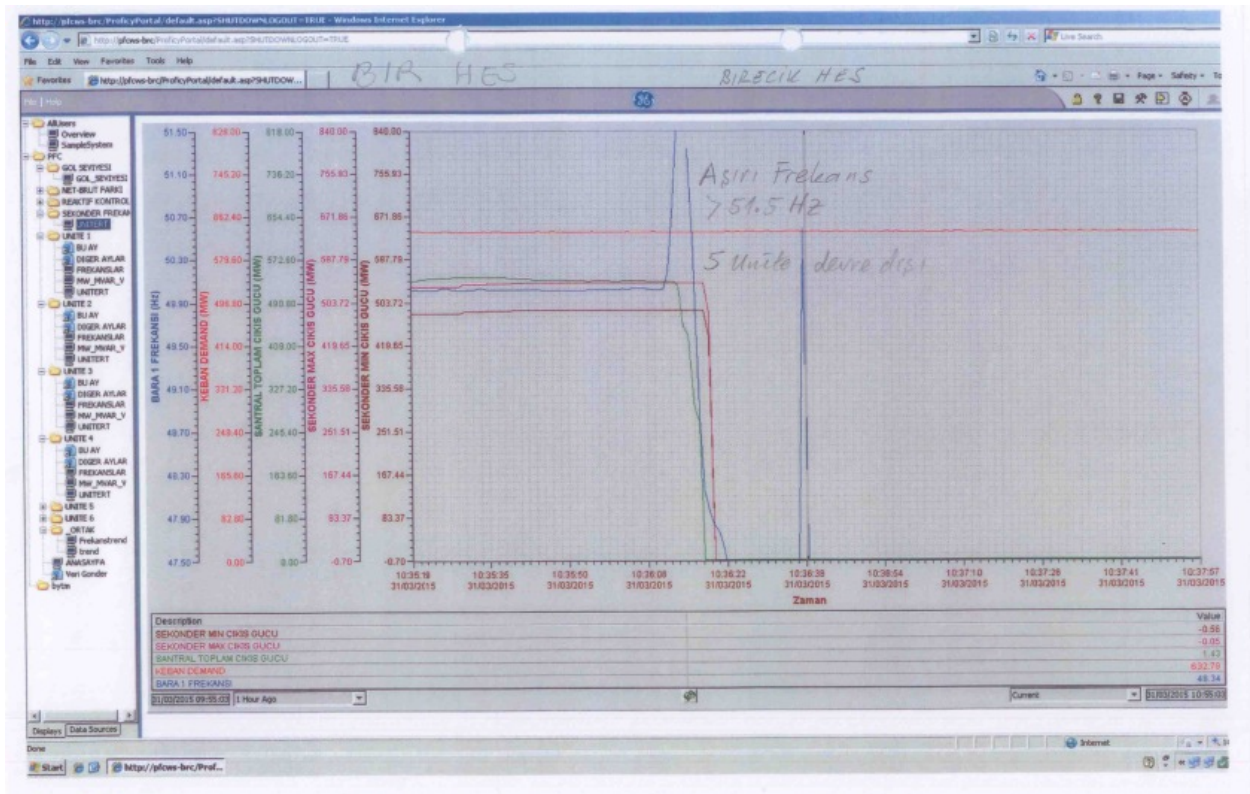
In the graph above:

Blue colour (Frekans) represents the network frequency

Each cell represents 1 second, (in total 160 seconds)

Appendix- 21: Power plant SCADA output of Birecik HPP during the blackout

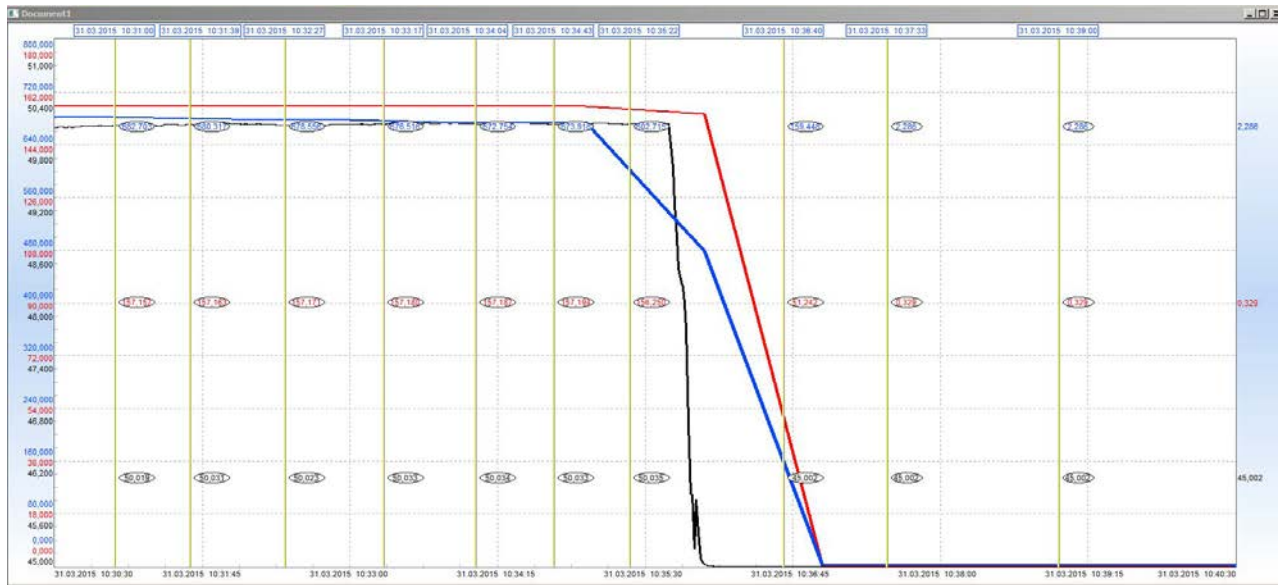
In the graph above:

Black colour represents the network frequency

Each cell (dashed vertical lines) represents 75 seconds, (in total 10 minutes)

Appendix- 22: Power plant SCADA output of Temelli NGCCPP during the blackout
