Report on Blackout in Turkey on 31st March 2015

– Final Version 1.0 –

Project Group Turkey

21 September 2015

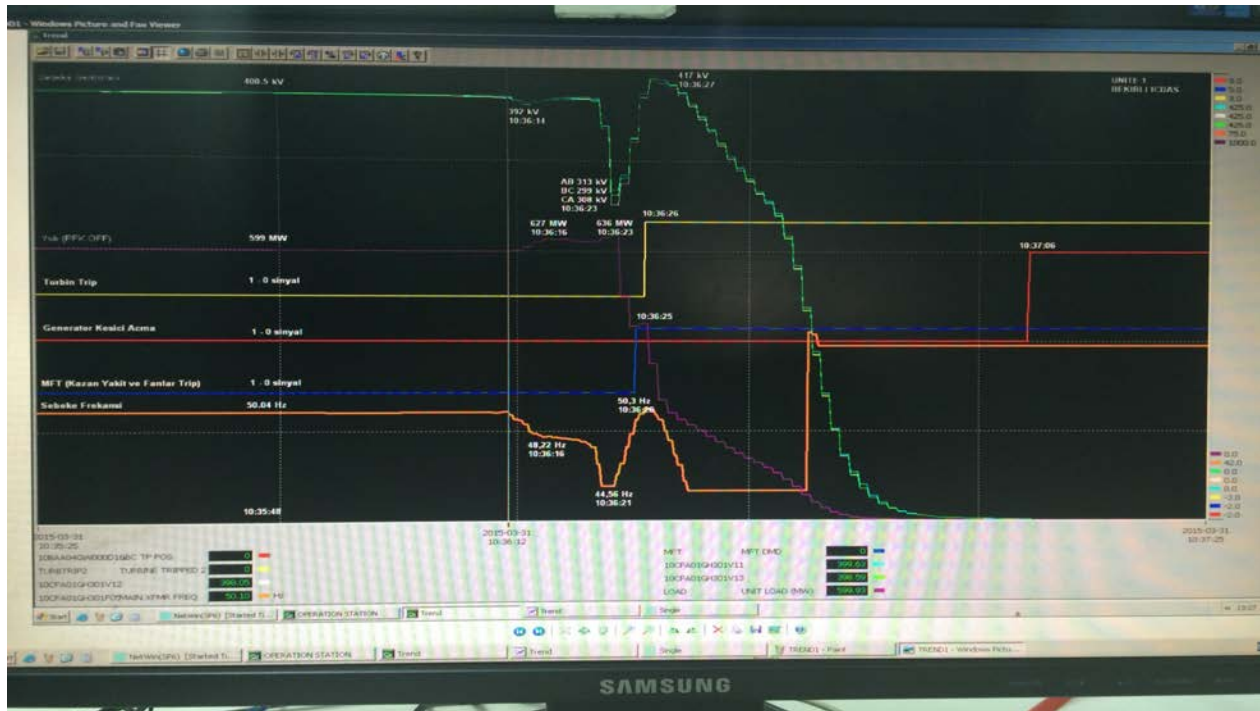
In the graph above:

Green colour (Şebeke Gerilimi) represents the network voltage where PP is connected

Each cell represents 24 seconds, (in total 96 seconds)

Appendix- 23: Power plant SCADA output of Bekirli TPP during the blackout

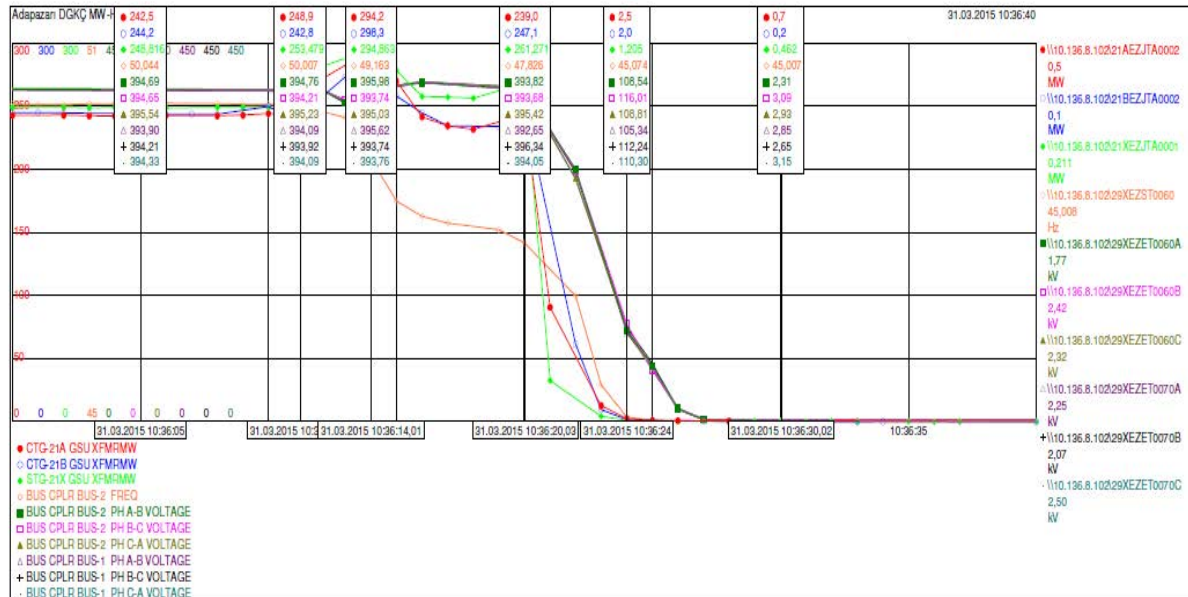
In the graph above:

Orange colour represents the network frequency

Each cell represents 5 seconds, (in total 40 seconds)

Appendix- 24: Power plant SCADA output of Adapazari NGCCPP during the blackout

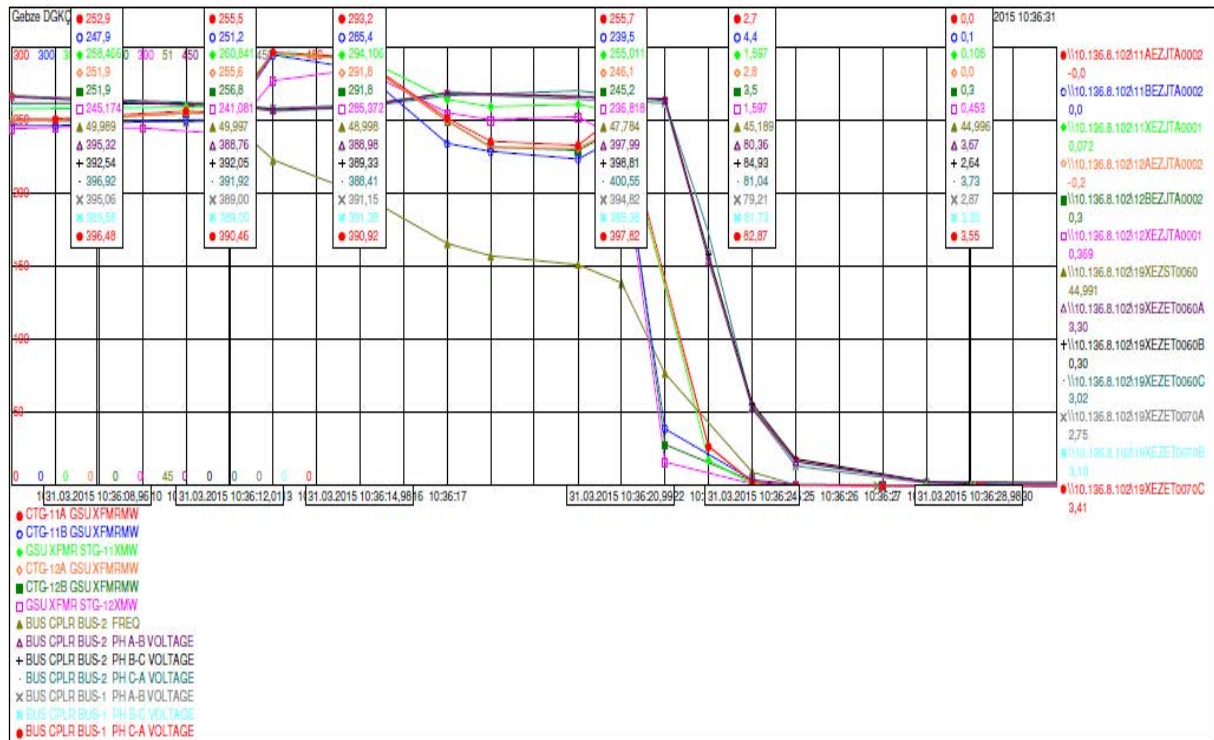
In the graph above:

Navy green colour represents the network frequency

Each cell represents 1 second, (in total 24 seconds)

Appendix- 25: Power plant SCADA output of Gebze NGCCPP during the blackout

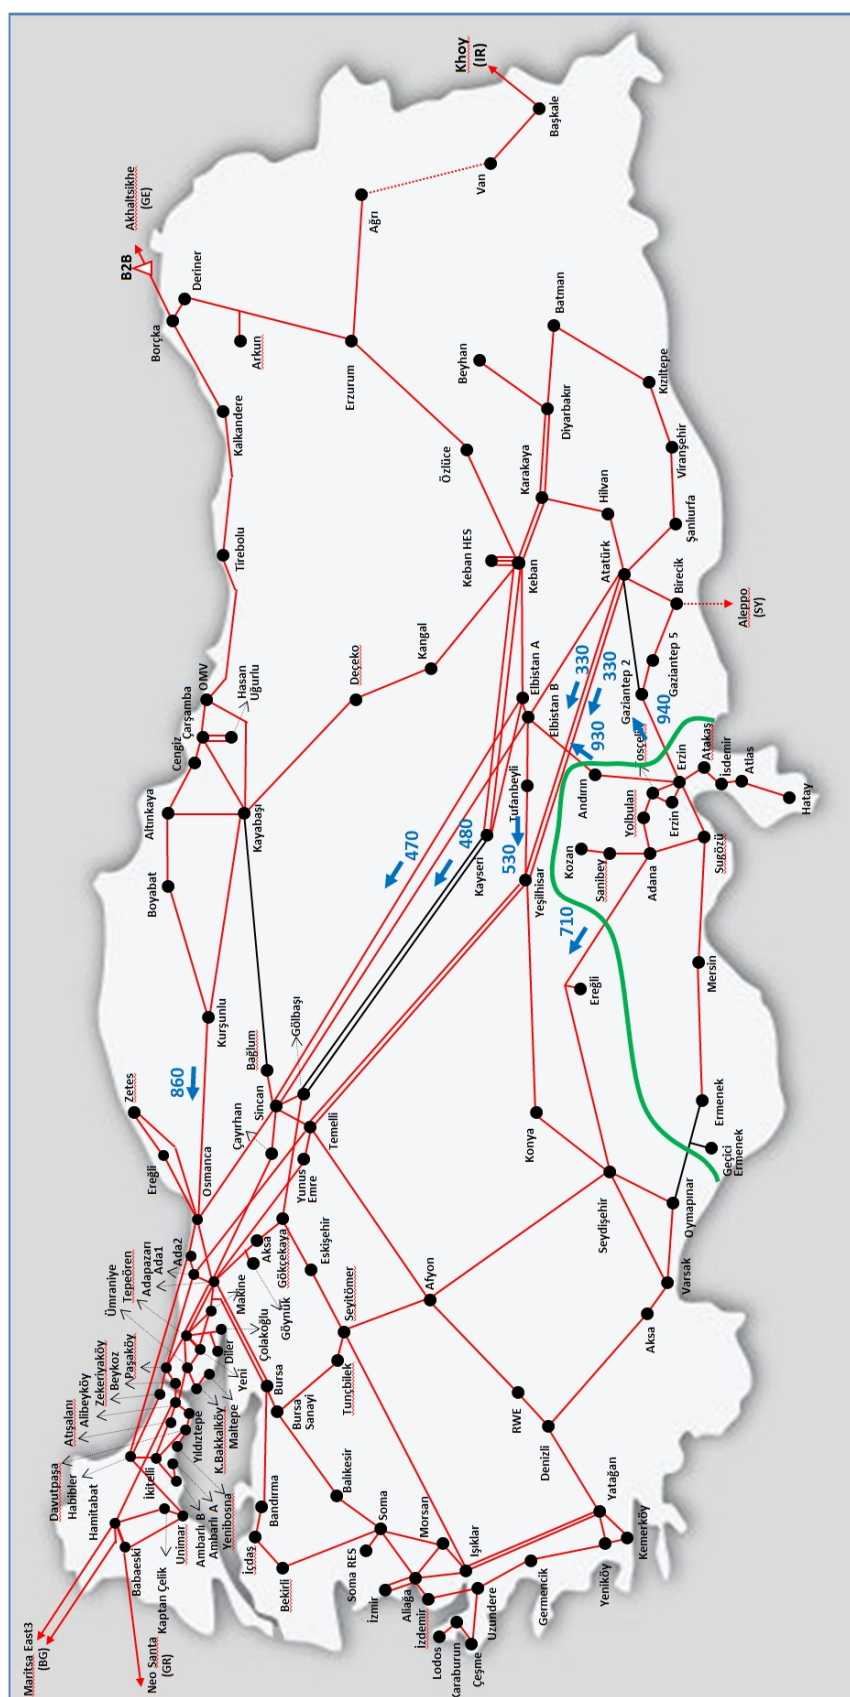
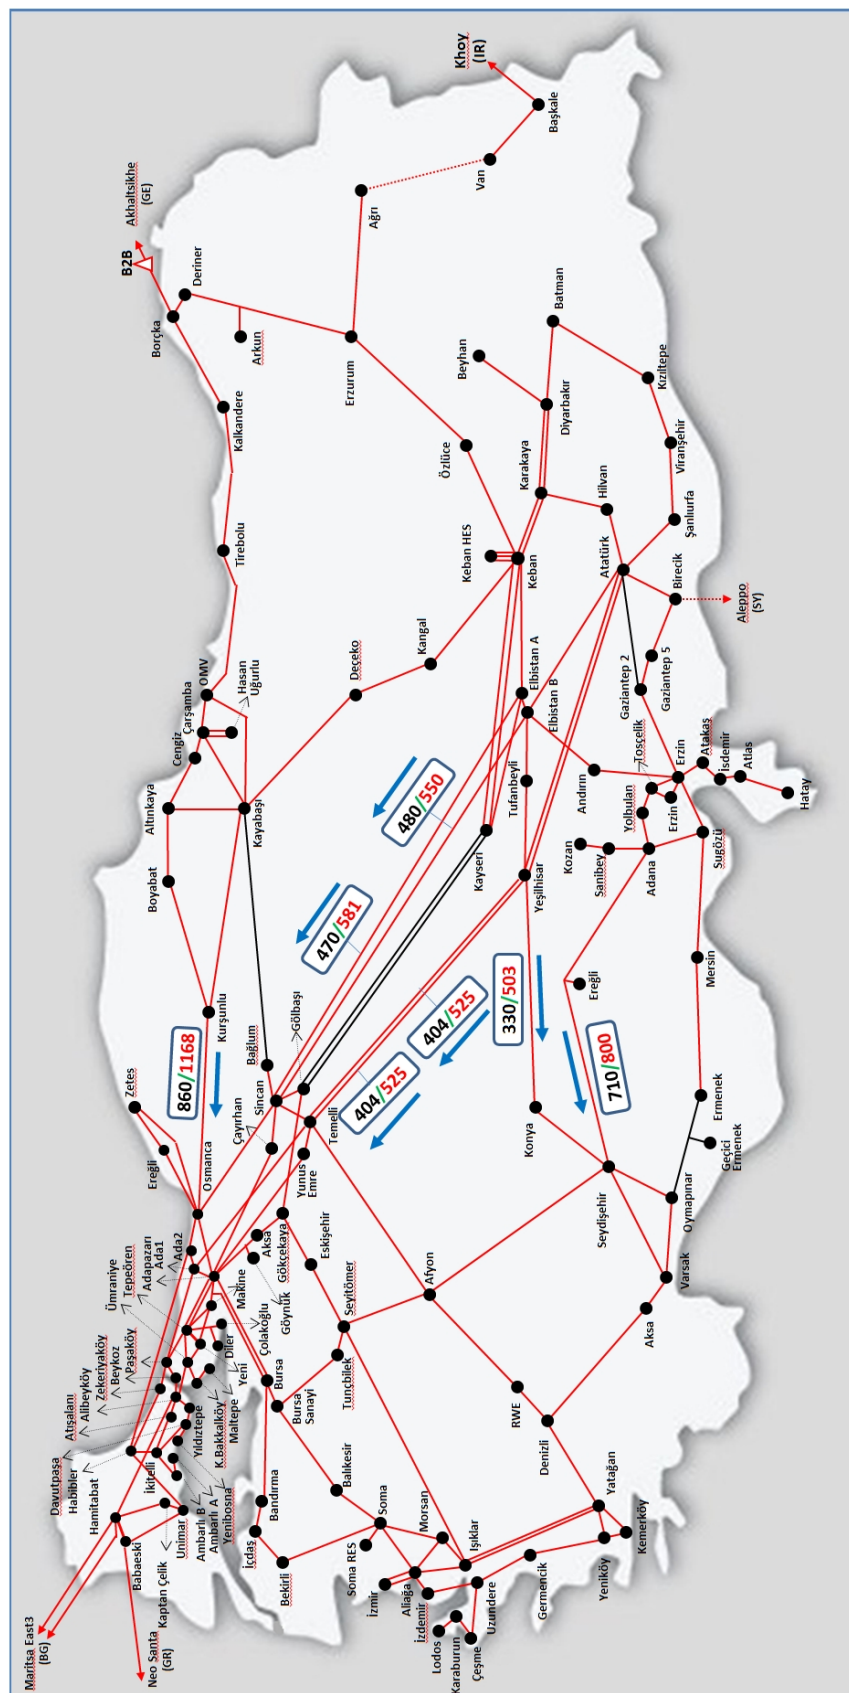
Appendix- 30: Comparison of power flows on 30th (black) and 31st March (red) 2015

- However, on March 31st, due to 1000 MW higher flow, the east-west voltage phase angle prior the event was significantly higher already exceeding the related stability limit after the first line trip. Dynamic calculations with the March 30th system pre-loading conditions reflect the fact that the stability limit was fulfilled even if one additional corridor line had been lost.
